AGENDA

REGULAR COUNCIL MEETING
Council Chambers
Friday, August 7th, 2020 – 1:00 p.m.

(i) **Sonya Clelland, Project Manager Englobe Corp. - North Bay re:**
[Draft Building Condition Assessment for the Municipal Office Building](#)

Building Condition Assessment

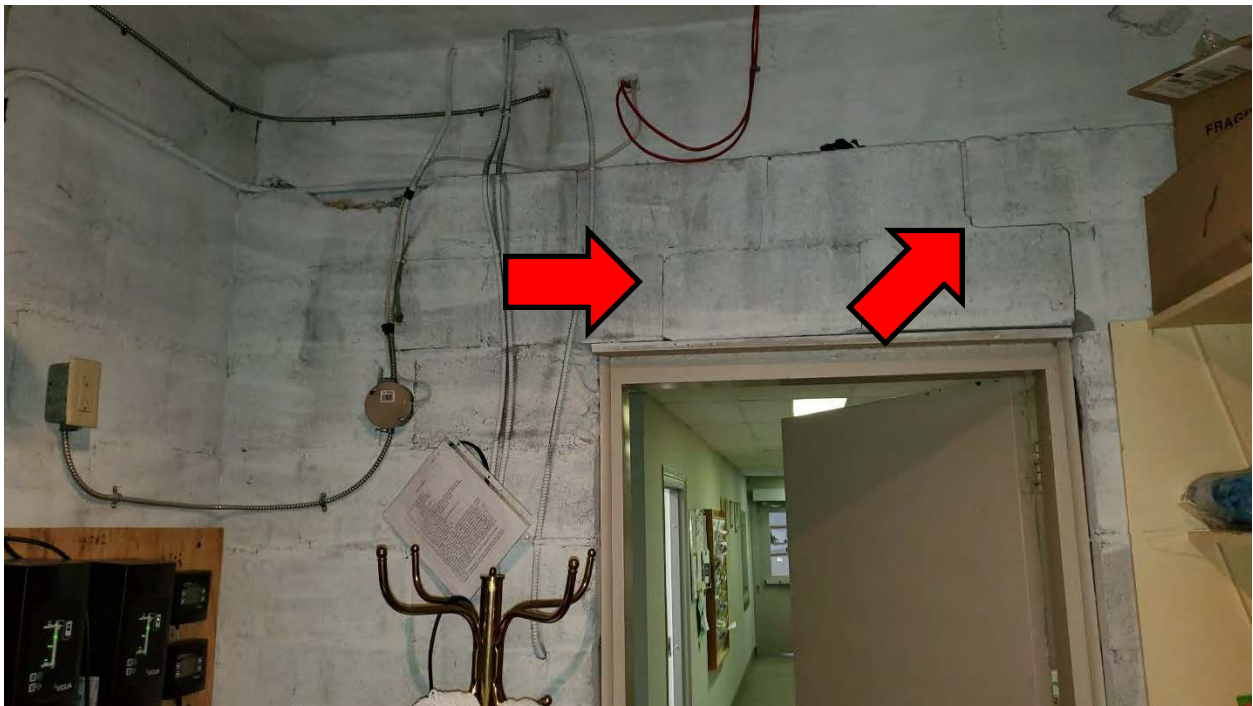
Figure 6: Municipal Office: Cracks in masonry over Mechanical Room door.

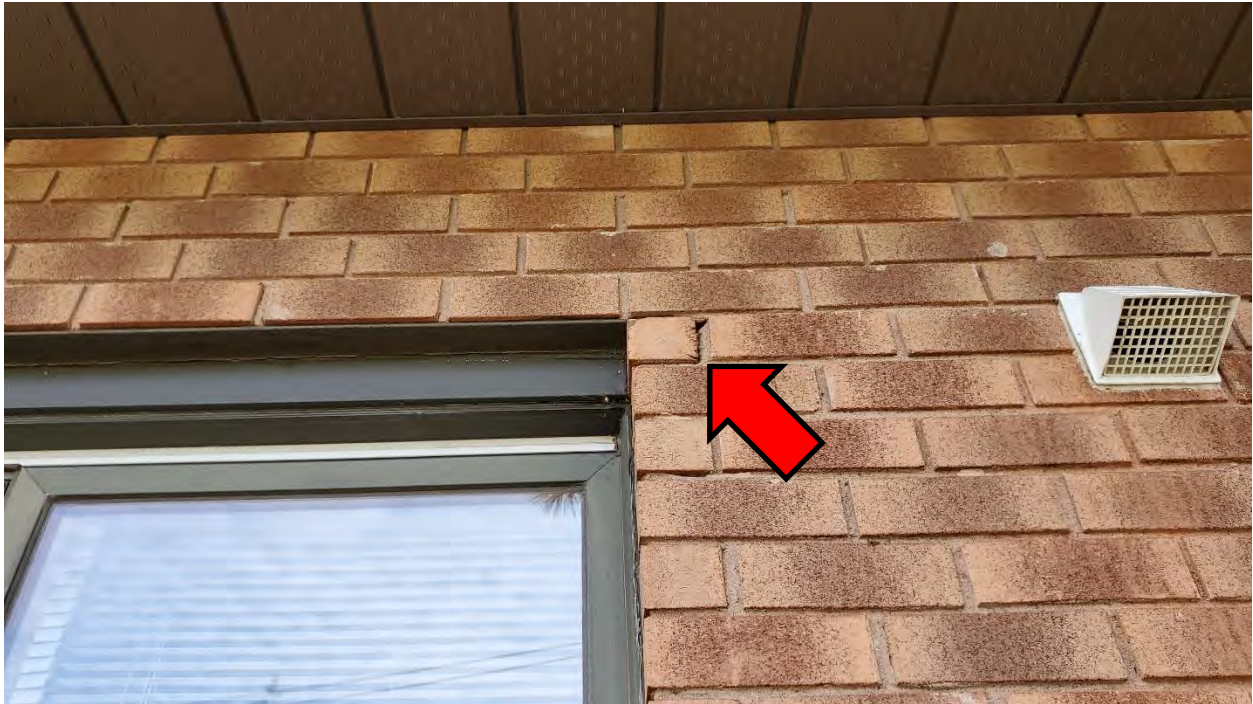
Figure 7: Municipal Office: Loose brick at lintel bearing on west elevation.

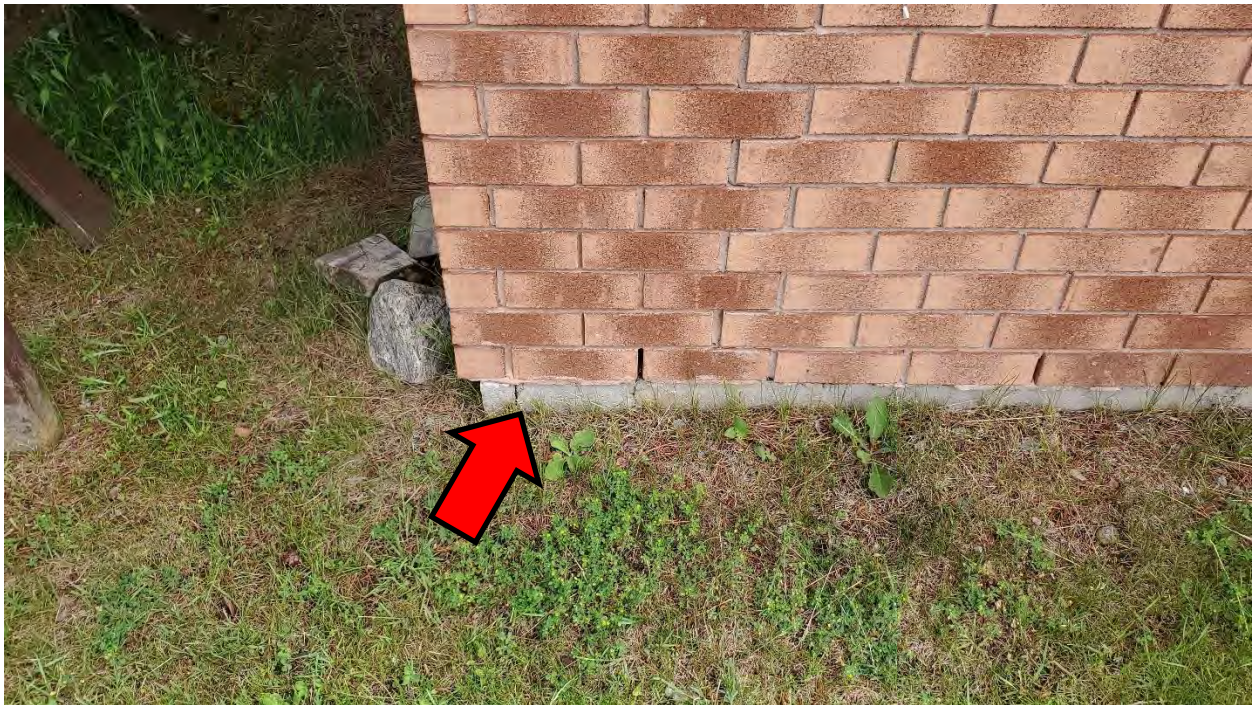
Figure 8: Municipal Office: Southwest corner. Crack in foundation wall.

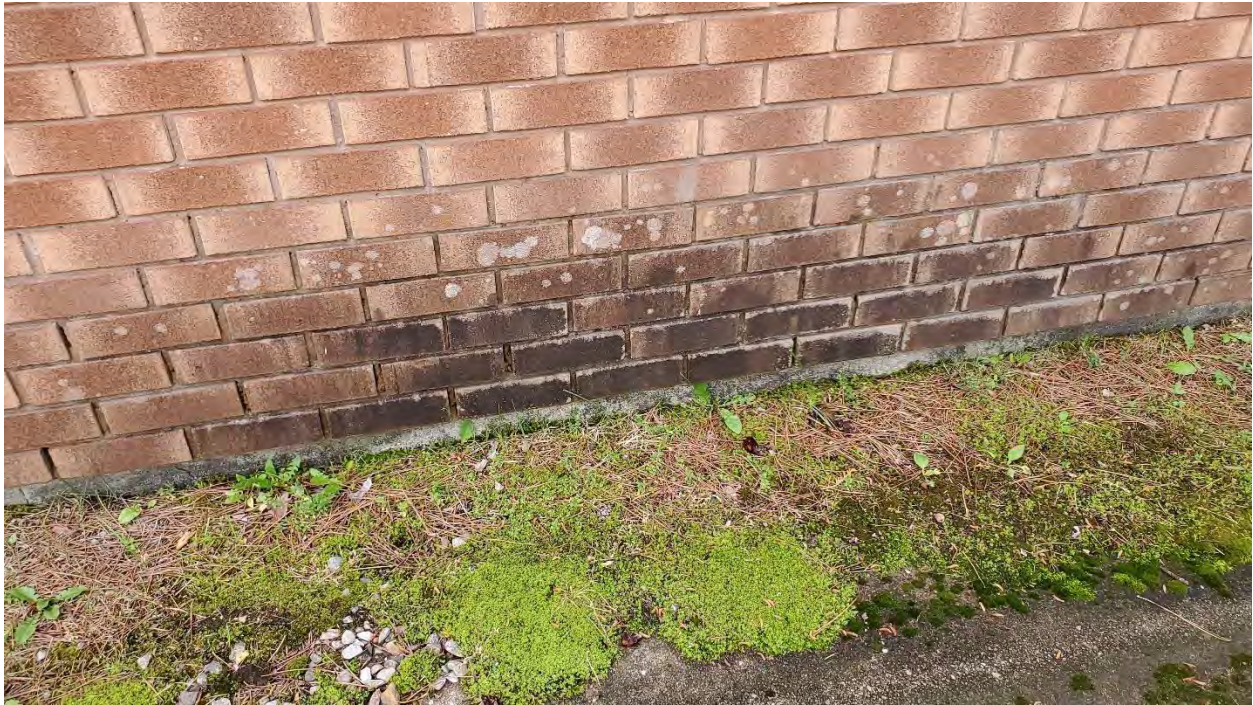
Figure 9: Municipal Office: Deteriorated mortar on the west elevation.

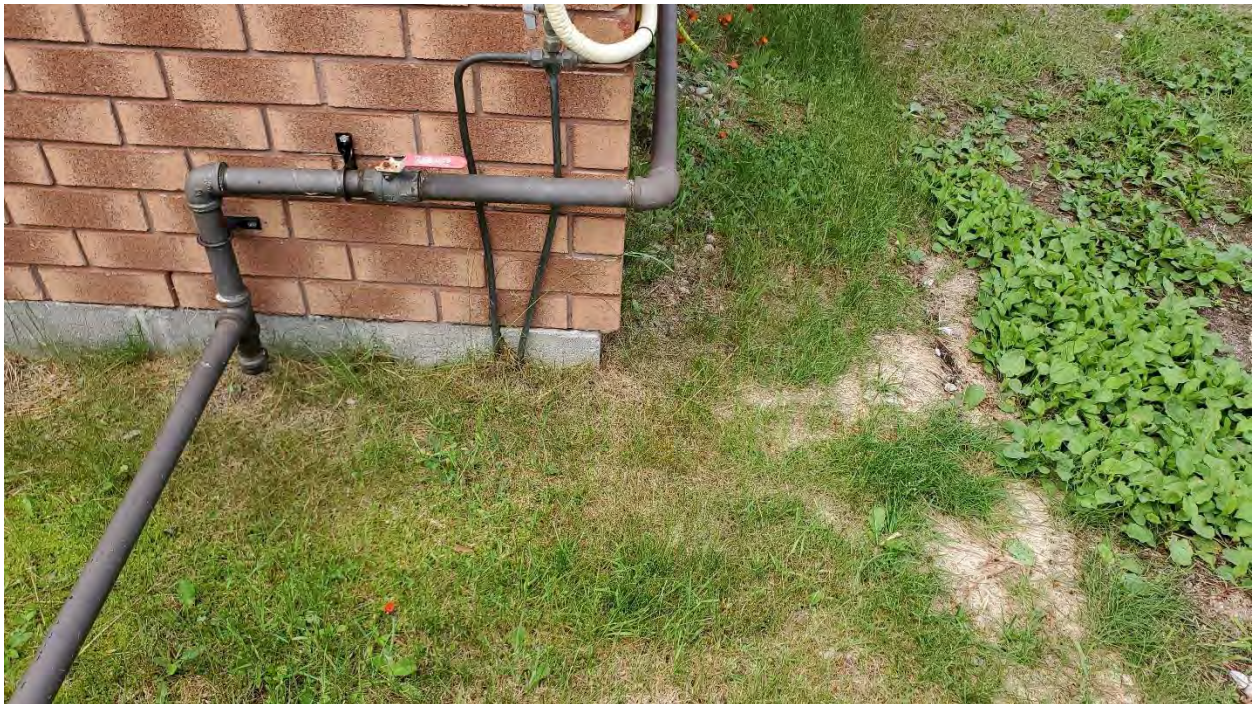
Figure 10: Municipal Office: Excessive brick projection beyond the foundation wall on the west elevation.

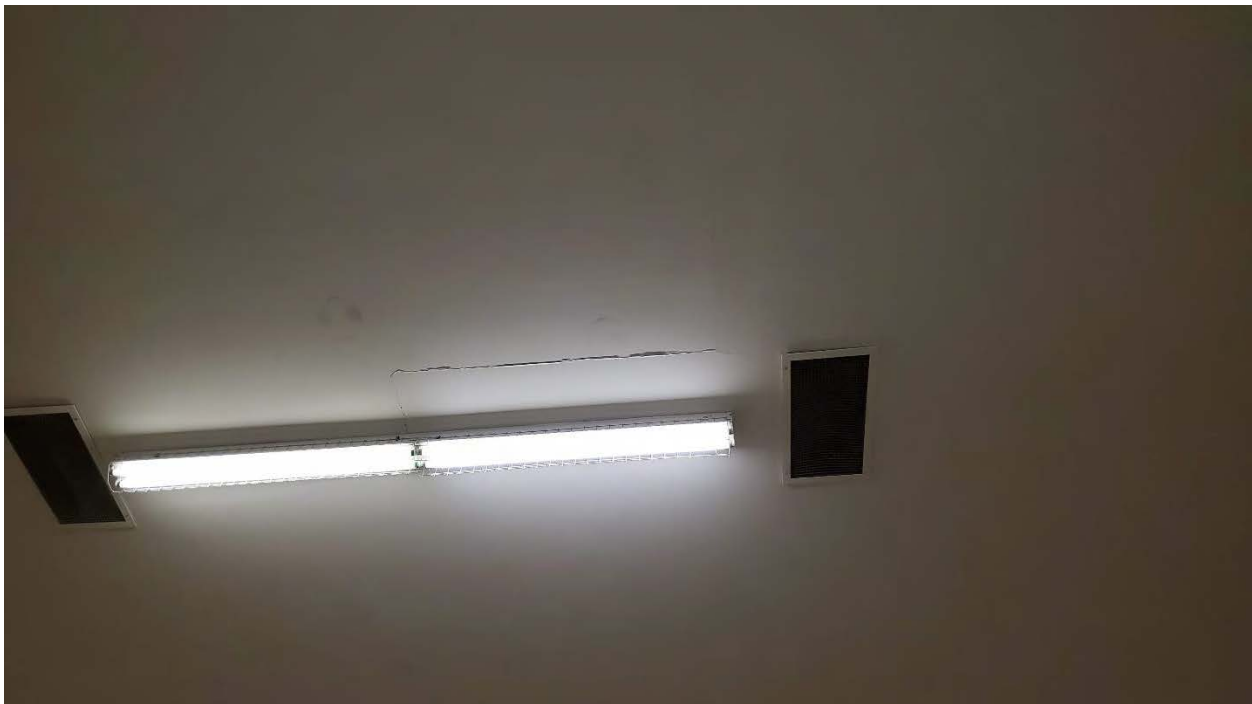
Figure 14: Community Hall Addition: Ceiling crack over Gymnasium.

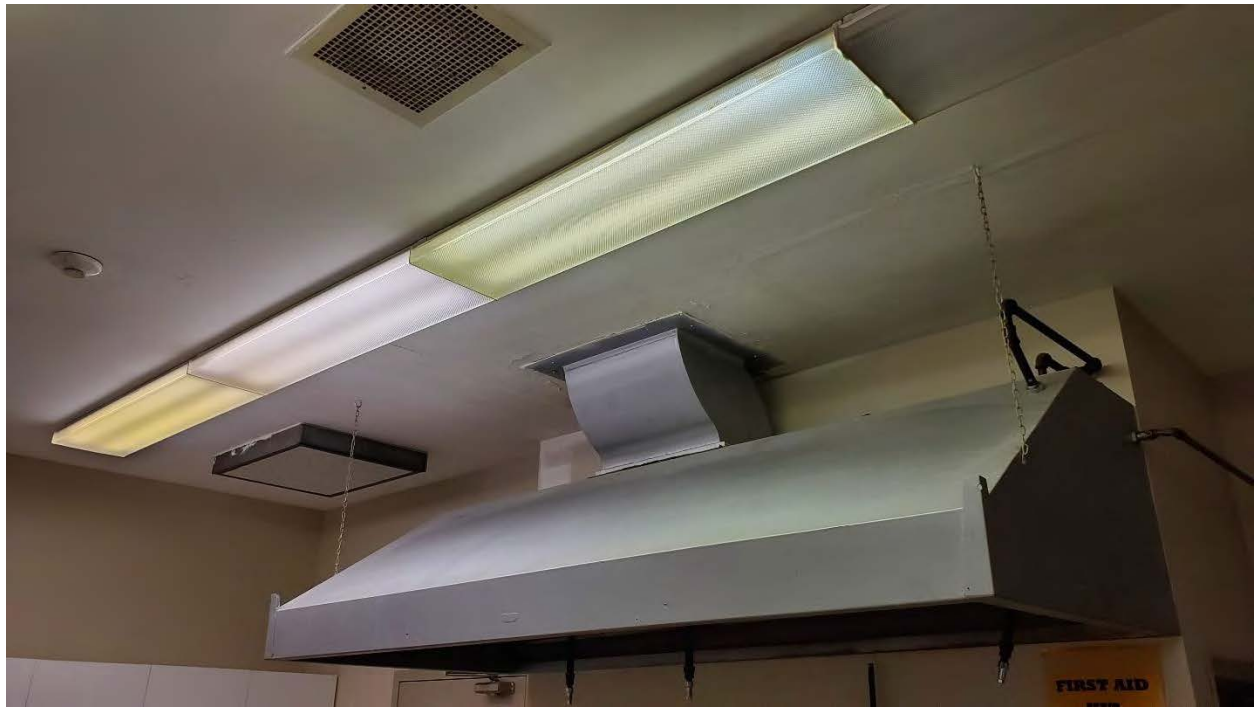
Figure 15: Community Hall Addition: Location of previous roof leakage in the Kitchen.

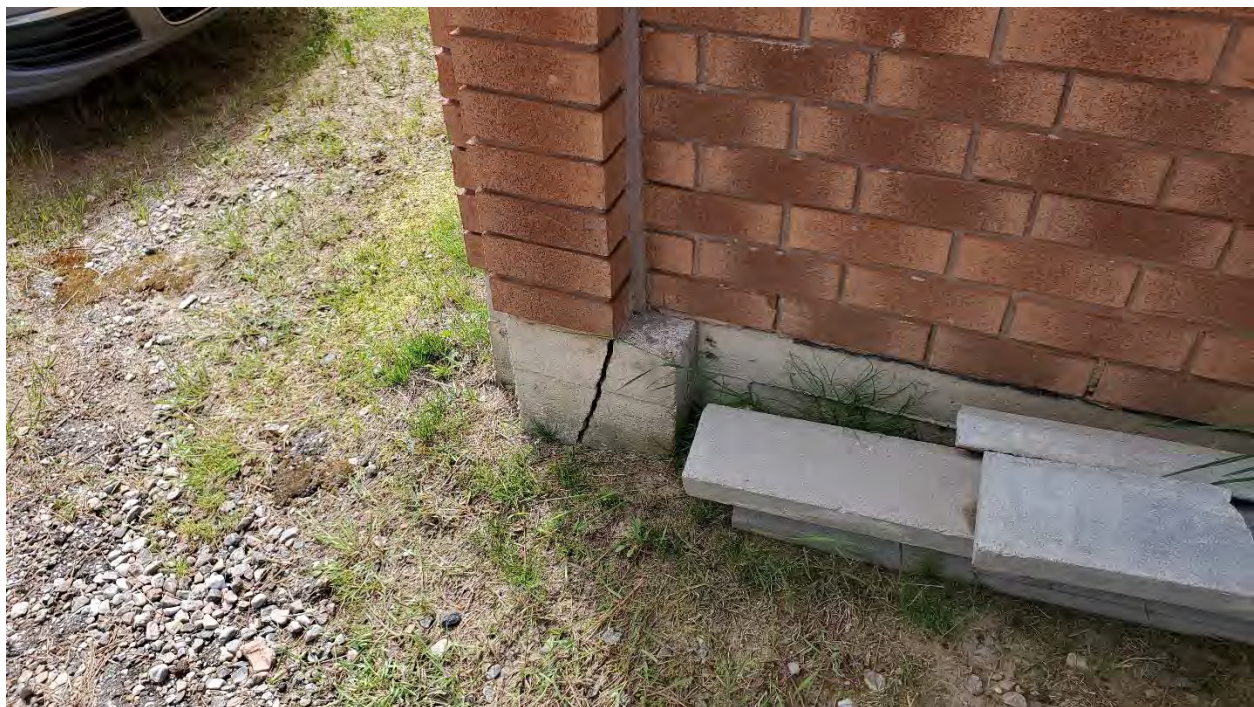
Figure 16: Community Hall Addition: Foundation crack at the northeast corner.

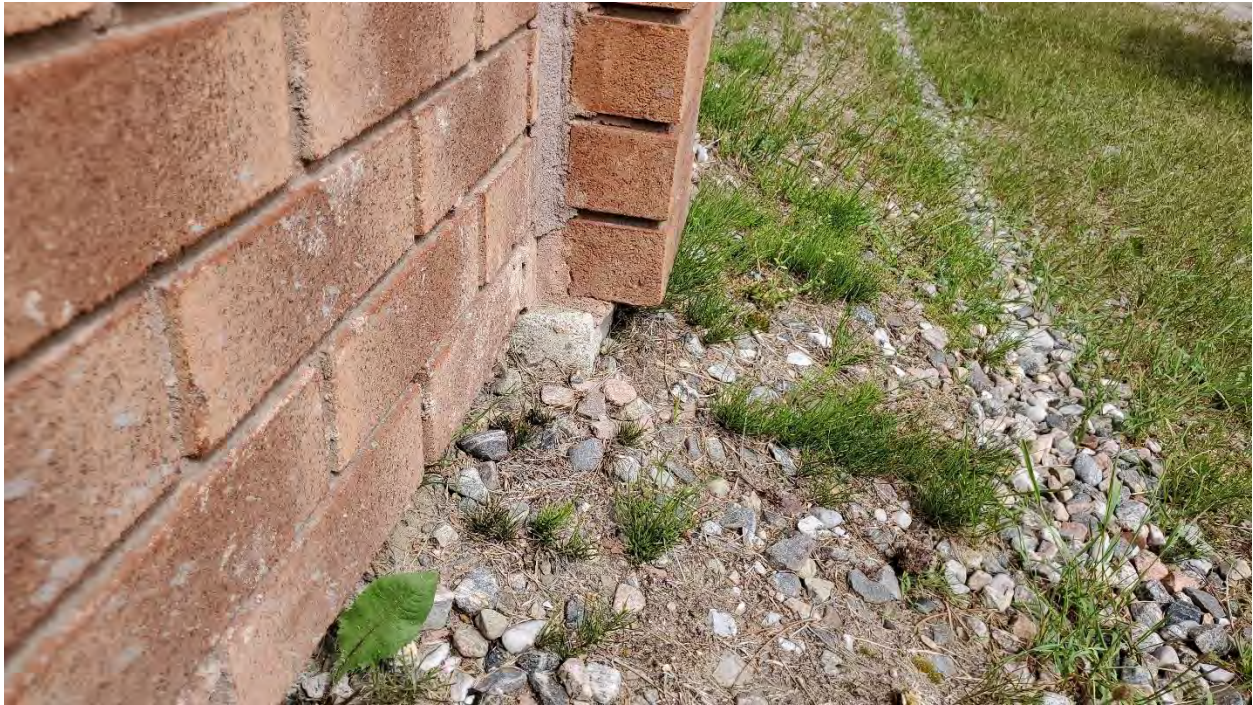
Figure 17: Community Hall Addition: Excessive brick projection beyond the foundation wall on the east elevation.

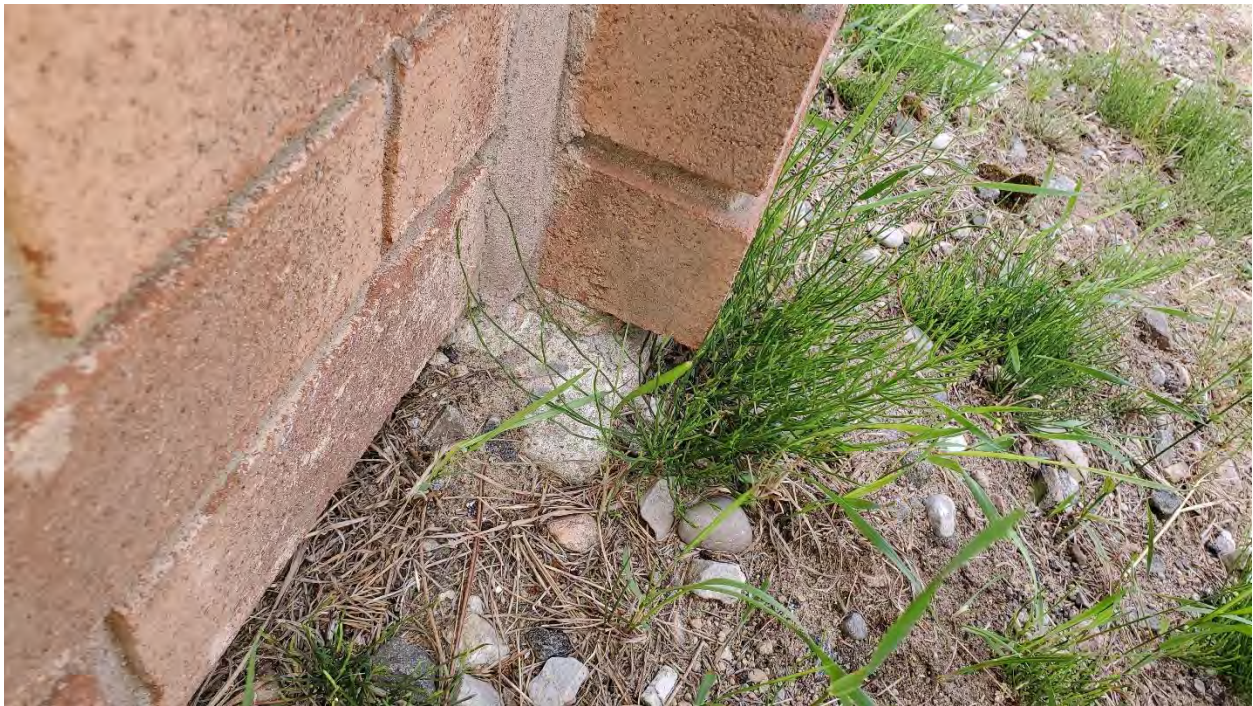
Figure 18: Community Hall Addition: Excessive brick projection beyond the foundation wall on the west elevation.

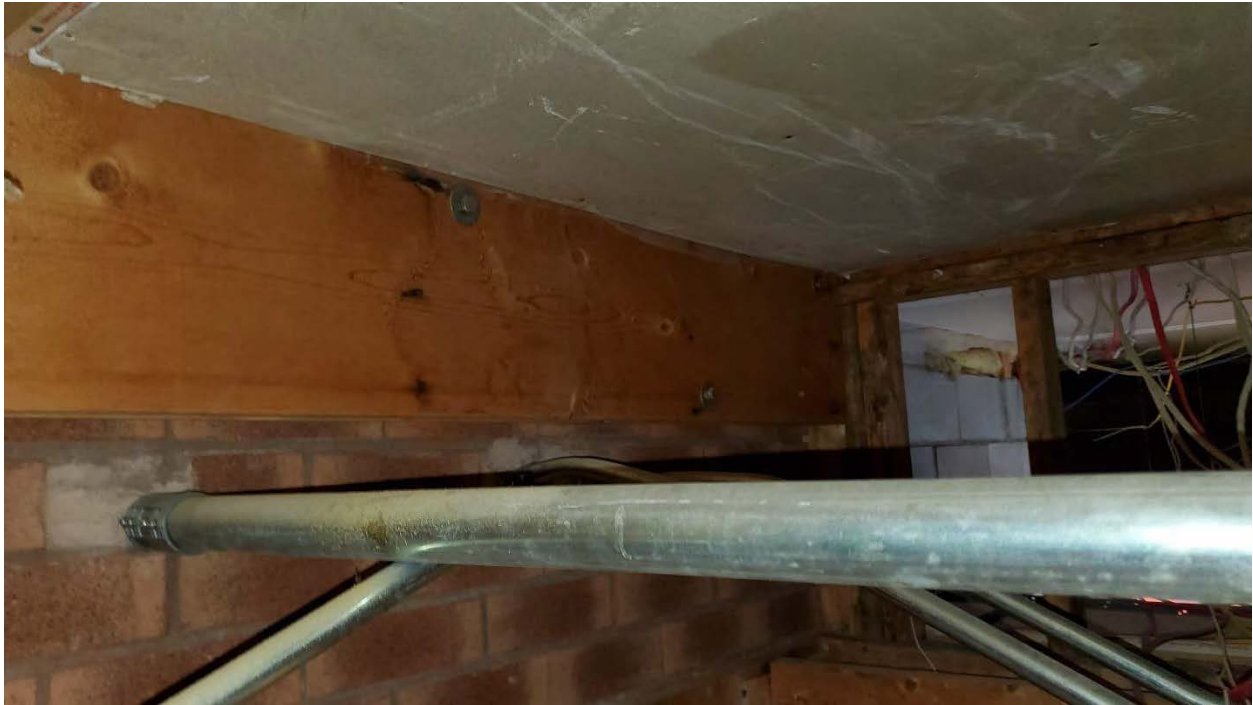
Figure 19: Electrical Room Addition: Wood ledger board bolted to brick cladding in the Electrical Room.

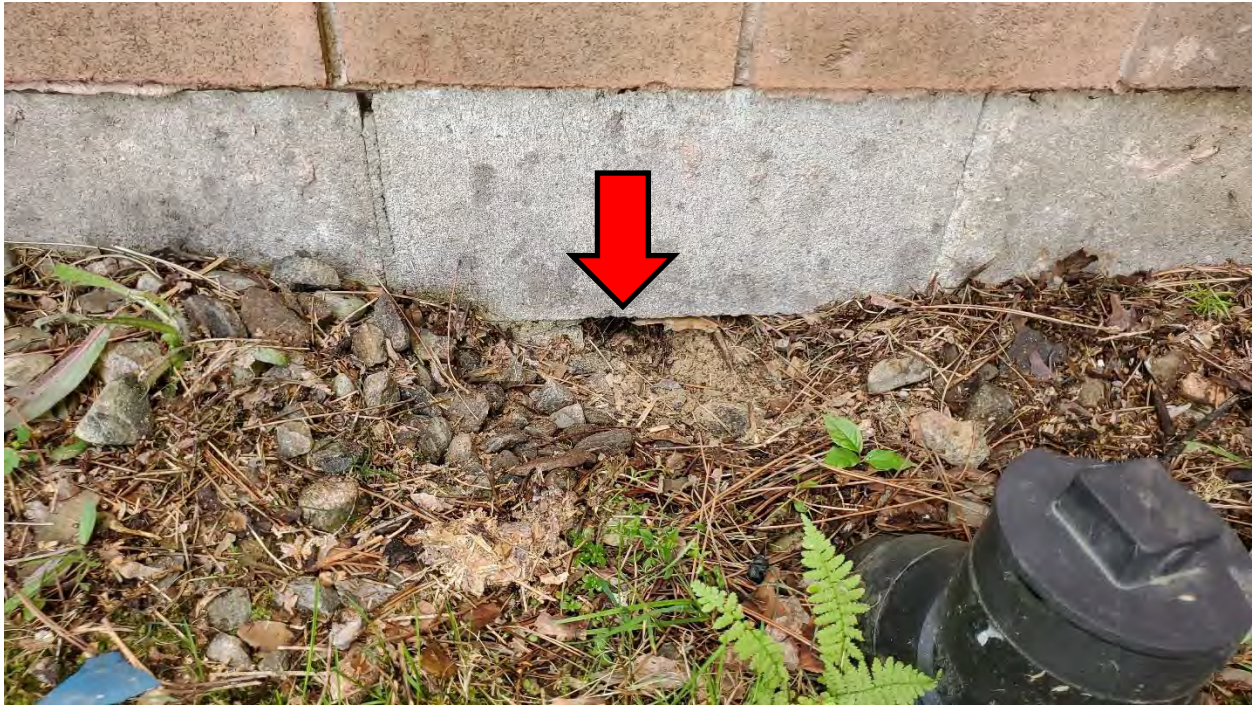
Figure 21: Electrical Room Addition: Hole in the foundation wall on the west elevation of the Electrical Room.

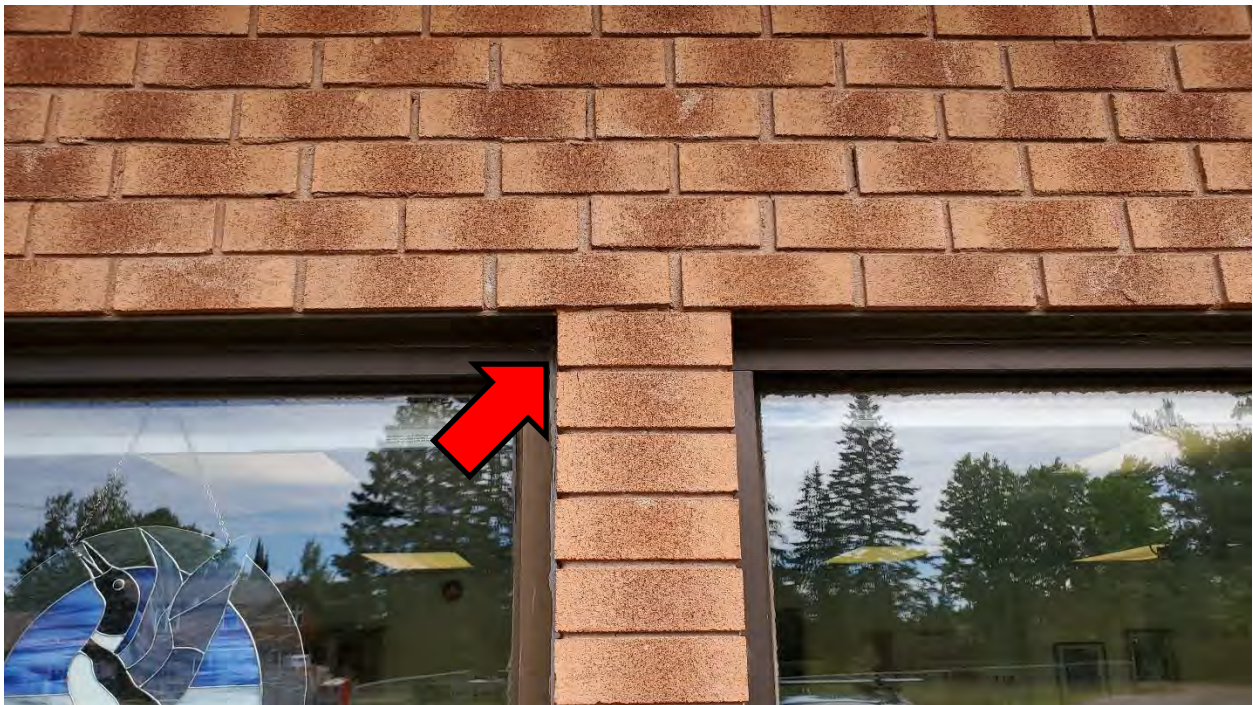
Figure 24: Community Hall Addition: Cracked bricks at lintel bearing.

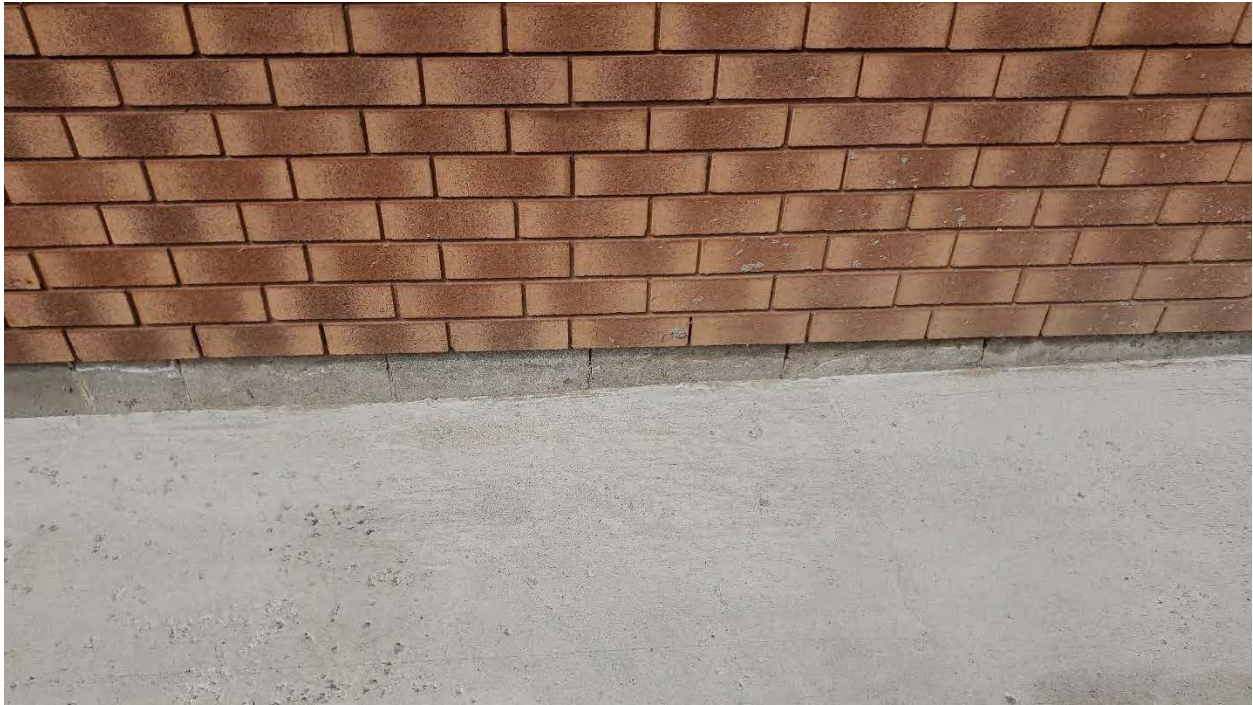
Figure 25: Community Hall Addition: Cracked mortar joints in the foundation wall on the east elevation.

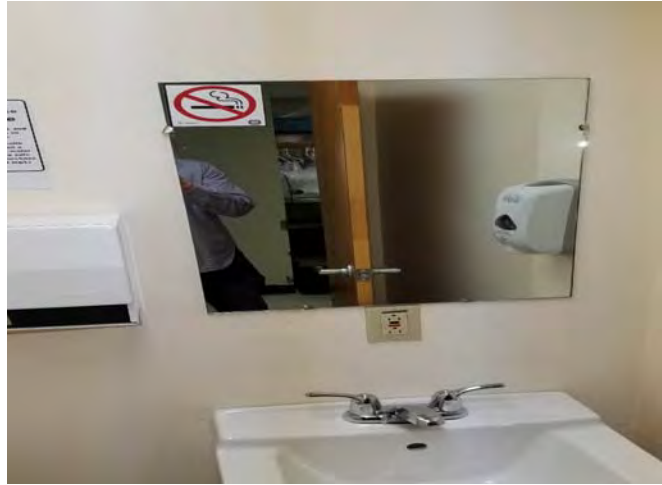
PHOTO OF PLUMBING FIXTURES (WASHROOM ACROSS THE GYM)

Plumbing fixtures are old. Toilets had some stains.
