AGENDA

REGULAR COUNCIL MEETING
Council Chambers
Friday, August 7th, 2020 – 1:00 p.m.

(i) **Sonya Clelland, Project Manager Englobe Corp. - North Bay re:**
[Draft Building Condition Assessment for the Municipal Office Building](#)

Building Condition Assessment

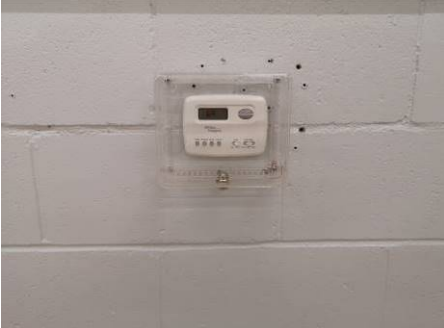
<p style="text-align: center;">07</p>	<p style="text-align: center;">Non-Mercury Containing Thermostat</p>

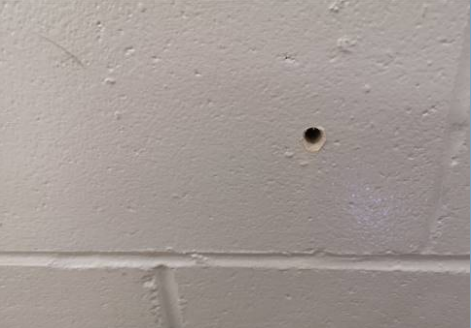
<p style="text-align: center;">08</p>	<p style="text-align: center;">Borehole Advanced Through North Wall Layers</p>

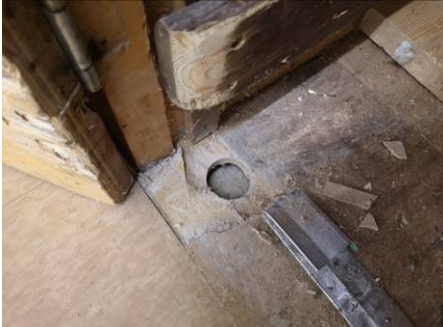
<p style="text-align: center;">09</p>
<p style="text-align: center;">Borehole Advanced Through Floor Layers</p>

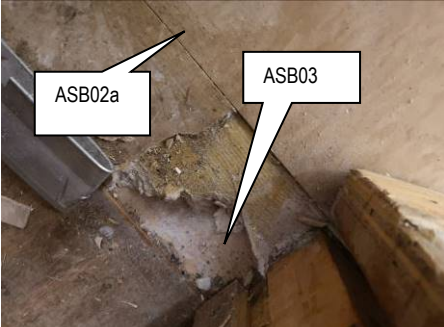
<p style="text-align: center;">10</p>

Location	Suspect Materials	Colour	Sample No.	Analytical Results % Type or ppm	Photo #	Friability	Condition Rating	Disruption Rating	Anticipated Removal Type
Floor - Below Stage	Vinyl Tile (12"x12")	Pink	ASB02a	None Detected	11	Friable	1	2	-
Floor – Near Gym Door Along South Wall	Vinyl Tile (12"x12")	Pink	ASB02b	None Detected	12	Friable	1	2	-
Floor – Stairs to Gym Stage	Vinyl Tile (12"x12")	Pink	ASB02c	None Detected	13	Friable	1	2	-
Below Vinyl Tile Floor	Fiberboard	White	ASB03a	None Detected	11	Friable	1	2	-
Below Vinyl Tile Floor	Fiberboard	White	ASB03b	None Detected	11	Friable	1	2	-
Below Vinyl Tile Floor	Fiberboard	White	ASB03c	None Detected	11	Friable	1	2	-
North Wall - East Door	Baseboard Mastic	White	ASB04a	None Detected	14	Friable	1	2	-
South Wall - South East Door	Baseboard Mastic	White	ASB04b	None Detected	15	Friable	1	2	-
South Wall - South West Door	Baseboard Mastic	White	ASB04c	None Detected	16	Friable	1	2	-

Ceiling Above Stage	Drywall Joint Compound	White	ASB05a	None Detected	17	Friable	1	2	-
Below ASB02b	Construction Mastic	Yellow	ASB06a	None Detected	11	Non-Friable	1	2	-

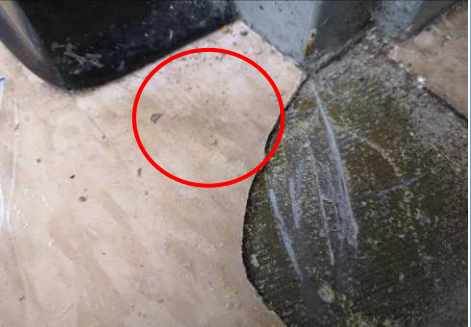
<p style="text-align: center;">11</p>

LOCATION/AREA:		Level 1 – Room # 1 – Gymnasium (Continued)					PHOTOS: 07 – 21			
Location	Suspect Materials	Colour	Sample No.	Analytical Results % Type or ppm	Photo #	Friability	Condition Rating	Disruption Rating	Anticipated Removal Type	
Below ASB02a	Construction Mastic	Yellow	ASB06b	None Detected	12	Non-Friable	1	2	-	
Below ASB02b	Construction Mastic	Yellow	ASB06c	None Detected	13	Non-Friable	1	2	-	
South Wall	Mortar	Grey	ASB10c	None Detected	18	Non-Friable	1	3	-	
Painted Tile on North Wall	Ceiling Tile (2'x4')	Brown	ASB15c	None Detected	19	Non-Friable	1	2	-	
South Side of Stage	Wall Paint	Grey	PB01	<77 ppm	20	-	-	-	-	
Ceiling	Ceiling Paint	White	PB02	<66 ppm	21	-	-	-	-

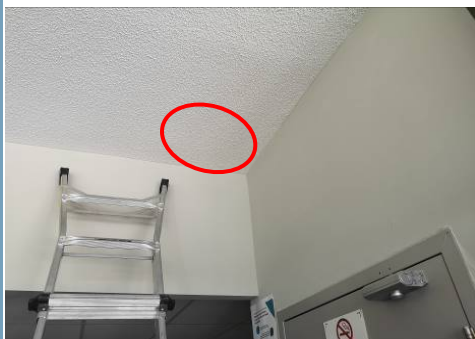
Location	Suspect Materials	Colour	Sample No.	Analytical Results % Type or ppm	Photo #	Friability	Condition Rating	Disruption Rating	Anticipated Removal Type
Ceiling – Inside of Lobby	Plaster	White	ASB19a	None Detected	57	Friable	1	2	-
Ceiling – North Side	Plaster	White	ASB19b	None Detected	58	Friable	1	2	-
Ceiling – South Side	Plaster	White	ASB19c	None Detected	59	Friable	1	2	-

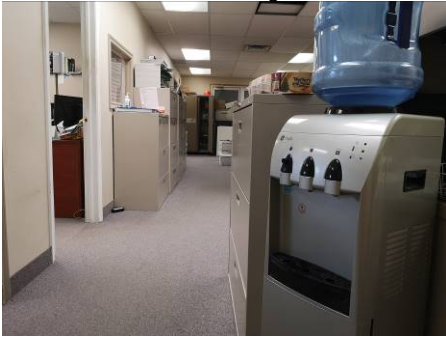
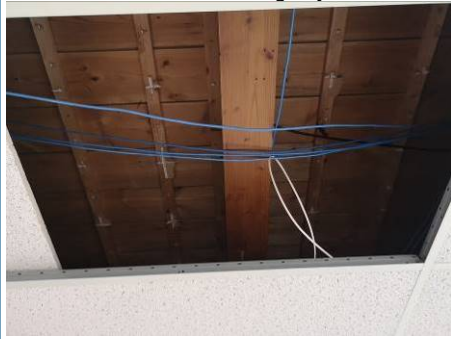
<u>LOCATION/AREA:</u>		Level 1 – Room # 12 – Offices					PHOTOS: 72 – 74			
<u>Notes</u>										
Only those building materials identified as a suspect Asbestos Containing Material (ACM) and sampled have been listed. See full list for confirmed ACMs potentially present in this area.										
Overview Facing East			Overview of Ceiling Layers

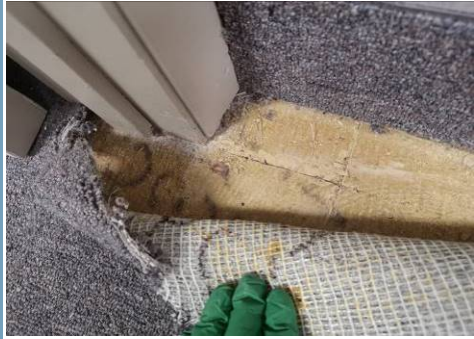
72			73				74			
Location	Suspect Materials	Colour	Sample No.	Analytical Results % Type or ppm	Photo #	Friability	Condition Rating	Disruption Rating	Anticipated Removal Type	
Below Carpet	Carpet Adhesive	Yellow	ASB17c	None Detected		Non-Friable	1	2	-	
Below Carpet	Vinyl Tile	White	ASB21b	4.0% Chrysotile	74	Non-Friable	1	3	2 or 3	
Below Carpet	Vinyl Tile	White	ASB21c	Sample Not Analyzed, See ASB21b	74	Non-Friable	1	2	-

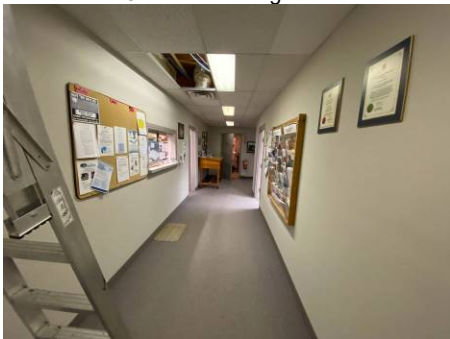
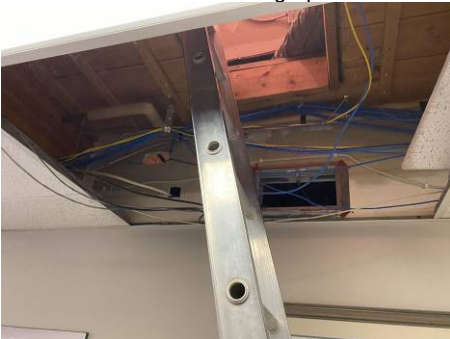
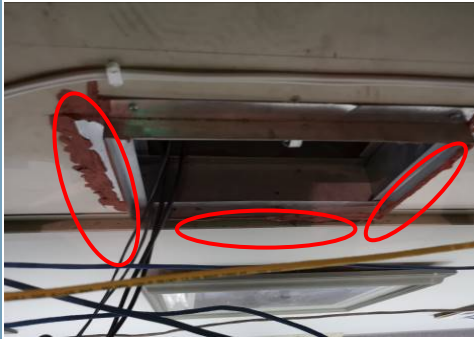
LOCATION/AREA:		Level 1 – Room # 13 – Corridor					PHOTOS: 75 – 77			
Notes										
Only those building materials identified as a suspect Asbestos Containing Material (ACM) and sampled have been listed. See full list for confirmed ACMs potentially present in this area.										
Overview Facing East			Overview of Ceiling Space

75			76				77			
Location	Suspect Materials	Colour	Sample No.	Analytical Results % Type or ppm	Photo #	Friability	Condition Rating	Disruption Rating	Anticipated Removal Type	
Around Vent, Above, Ceiling Tile	Caulking	Red	ASB22a	None Detected	77	Non-Friable	1	2	-	
Around Vent, Above, Ceiling Tile	Caulking	Red	ASB22b	None Detected	77	Non-Friable	1	2	-	
Around Vent, Above, Ceiling Tile	Caulking	Red	ASB22c	None Detected	77	Non-Friable	1	2	-

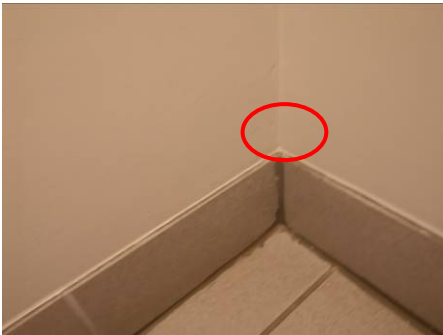
<p>86</p>

Location	Suspect Materials	Colour	Sample No.	Analytical Results % Type or ppm	Photo #	Friability	Condition Rating	Disruption Rating	Anticipated Removal Type
Women's Washroom West Wall	Drywall Joint Compound	White	ASB05f	None Detected	86	Friable	1	2	-
Women's Washroom Ceiling	Ceiling Tile (2'x4')	Brown	ASB09c	None Detected	87	Friable	1	2	-
Multiuse Washroom Around Sink	Caulking	White	ASB28a	None Detected	88	Non-Friable	1	3	-
Sublayer of ASB28a, Identified by the Laboratory	Drywall Joint Compound	White	ASB28a	None Detected	88	Non-Friable	1	3	-
Men's Washroom Around the Sink	Caulking	White	ASB28b	None Detected	89	Non-Friable	1	3	-
Women's Washroom Around the Sink	Caulking	White	ASB28c	None Detected	90	Non-Friable	1	3	-
Women's Washroom Around Baseboard Tile – West Side	Caulking	Grey	ASB29a	None Detected	91	Non-Friable	1	3	-
Women's Washroom Around Baseboard Tile – East Side	Caulking	Grey	ASB29b	None Detected	92	Non-Friable	1	3	-

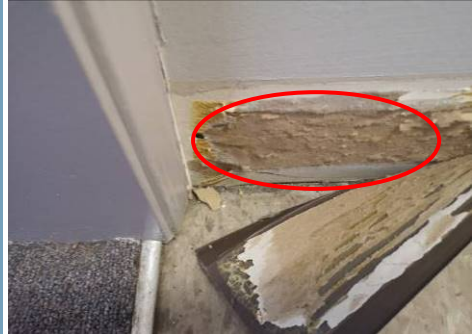
<p style="text-align: center;">96</p>

Location	Suspect Materials	Colour	Sample No.	Analytical Results % Type or ppm	Photo #	Friability	Condition Rating	Disruption Rating	Anticipated Removal Type
Behind Northwest Baseboard	Construction Mastic	Yellow	ASB07c	None Detected	96	Non-Friable	1	2	-
Floor	Vinyl Tile (12"x12")	Brown	ASB16b	None Detected	97	Non-Friable	1	3	-
Floor	Vinyl Tile (12"x12")	Brown	ASB16c	None Detected	97	Non-Friable	1	3	-
Sublayer of ASB16c, Identified by the Laboratory	Construction Mastic	Black	ASB16ci	None Detected	96	Non-Friable	1	2	-

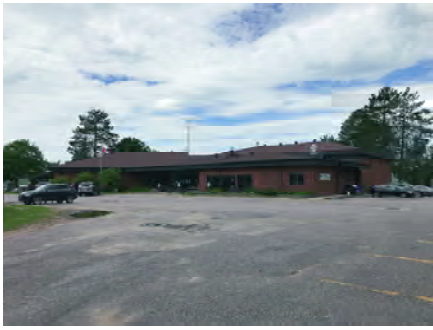
SITE001 - North East Parking Area

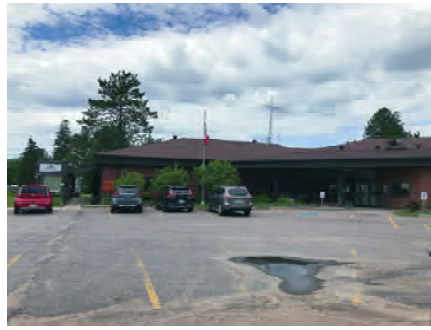
SITE002 - South East Parking Area

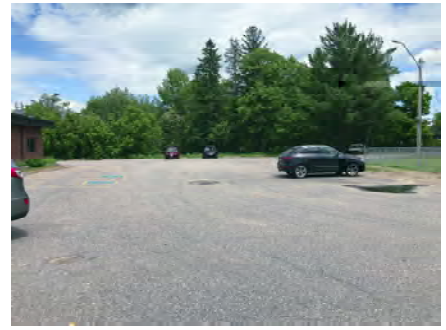
SITE003 - North East Parking Area

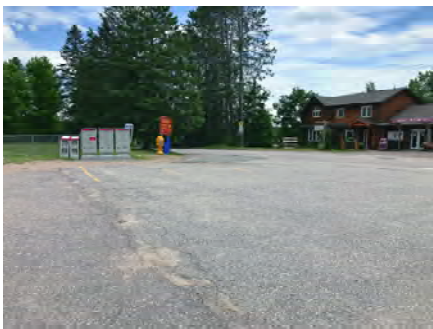
SITE004 - East Parking Area

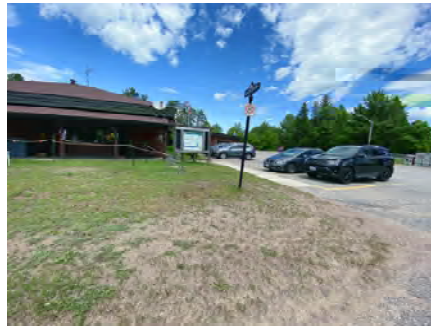
SITE005 - South Site Area looking North

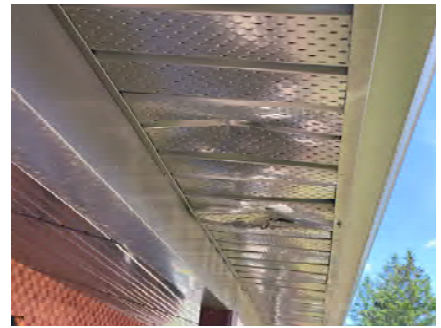
ES006 - Exterior Overhang Soffit Damage

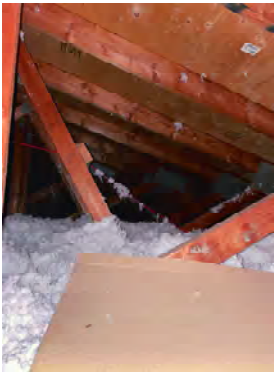
INT001 - Gymnasium Attic Space Trusses

4.2.22	Attic Spaces and Mechanical /HVAC Enclosure	INT001, INT002, INT003, INT004, INT005, INT006	Above Gymnasium	Attic areas are missing clearly defined service pathways. Attic insulation should be reinstalled, several areas have loosely piled batt and blanket insulation. Mechanical enclosure above gymnasium us constructed out of rigid foam board taped together. This does not comply by code as no thermal barrier is present.		x			x	x

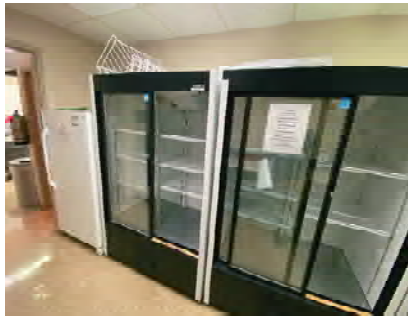
INT014 - Bar Coolers

4.2.24	Stairs	INT045	Gymnasium near Stage	Handrail does not meet current Code requirements.		x				x			
4.2.25	Kitchen Equipment	INT014, INT064, INT067, INT068, INT069, INT070, INT075, INT076, INT087	Kitchen, Bar, Kitchen Storage	Kitchen Equipment appears to be in a relatively fair / clean condition. Equipment in Bar appears to have exceeded its life expectancy.			x			x

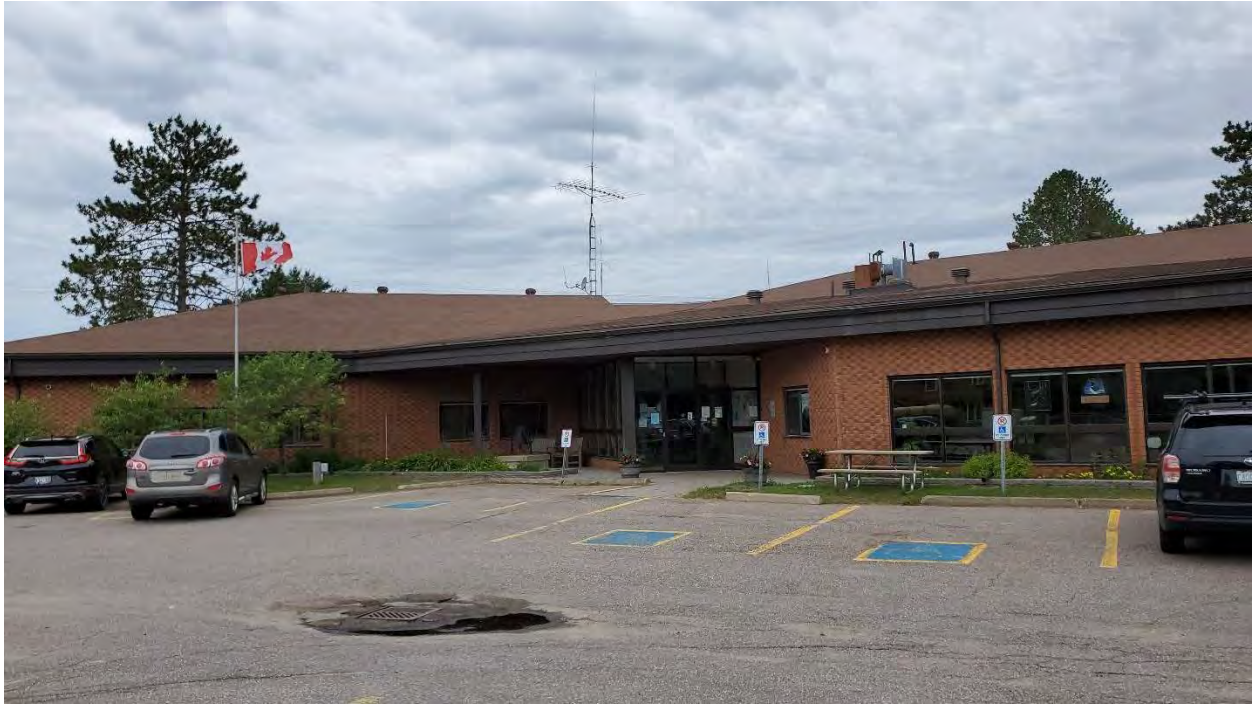
Figure 1: South elevation.

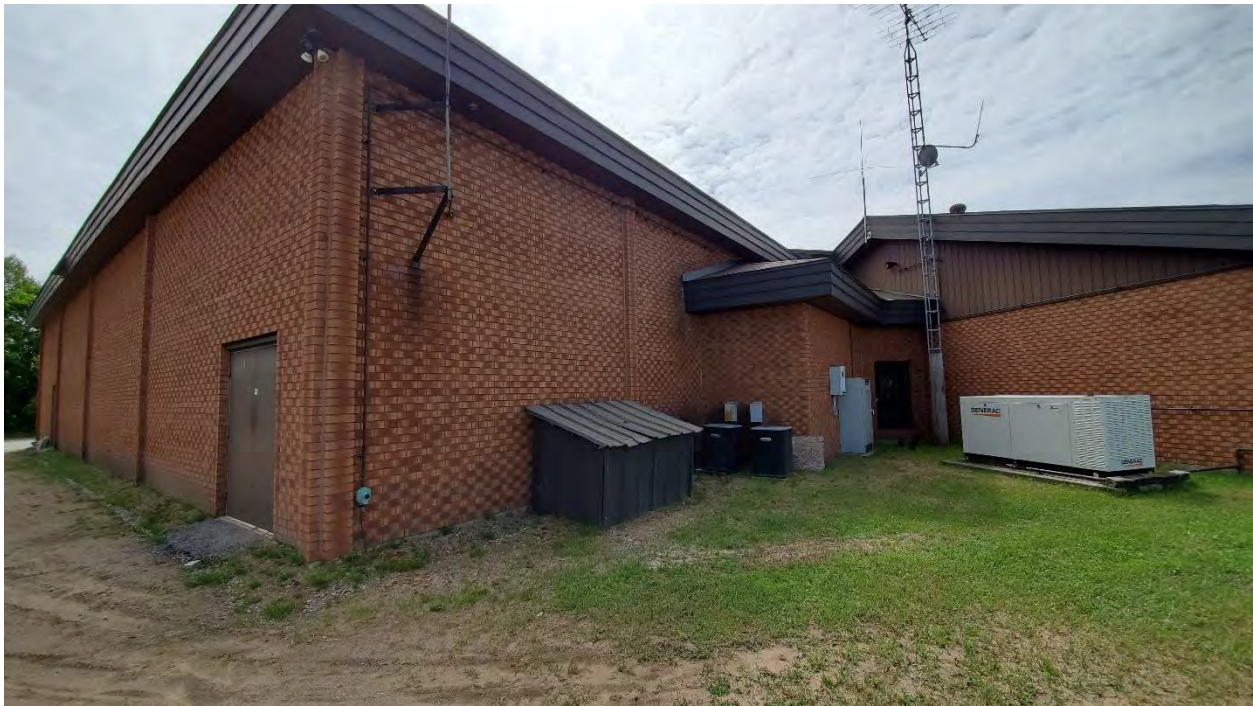
Figure 2: Northwest corner.

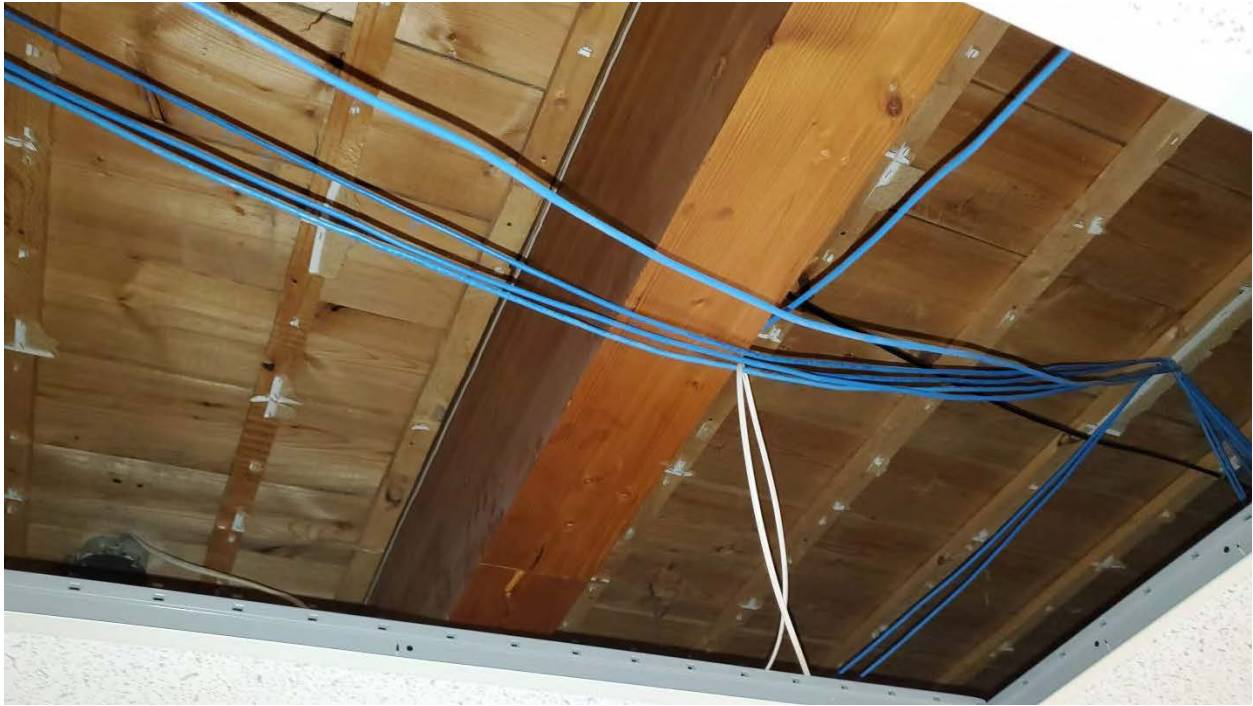
Figure 3: Municipal Office: Typical flat roof framing.

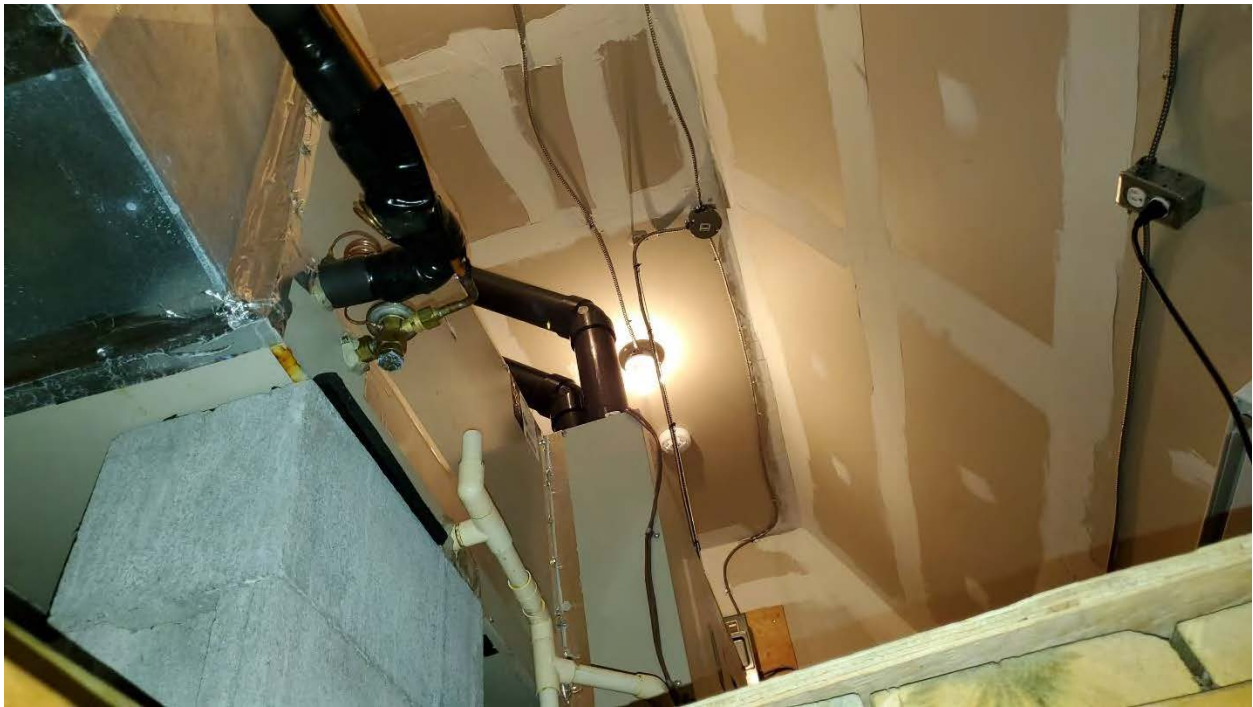
Figure 4: Municipal Office: Loft above the original flat roof framing.

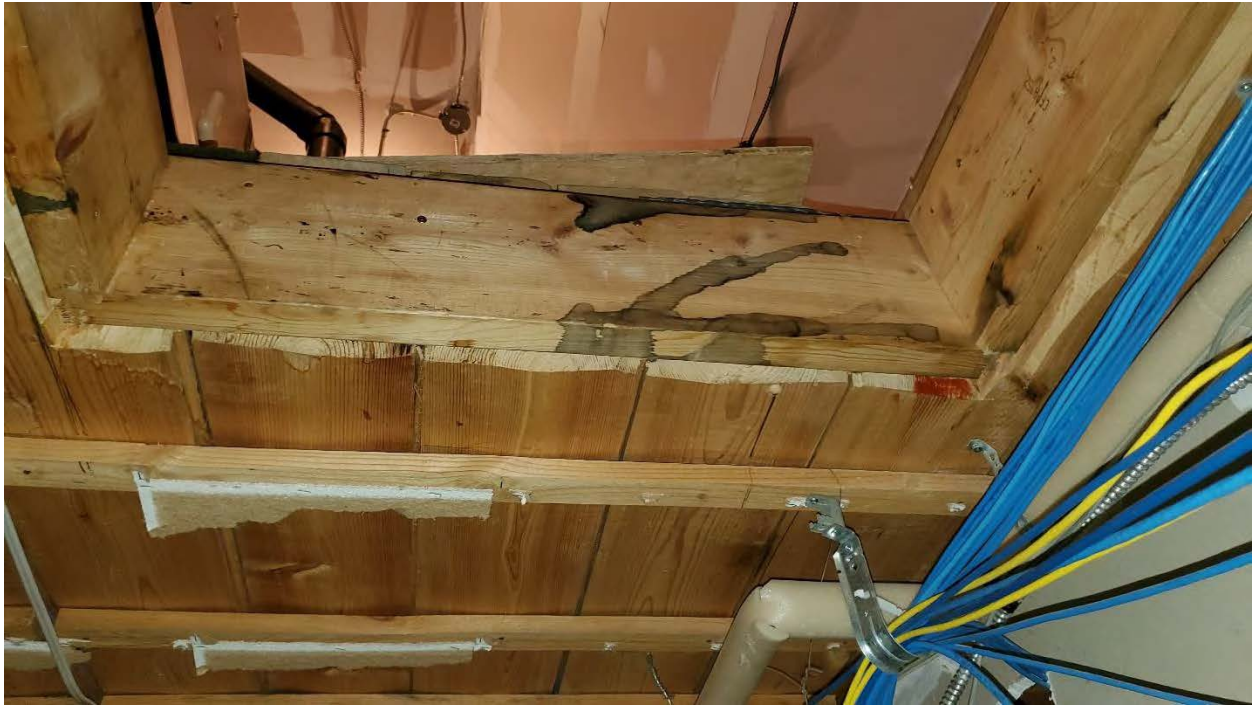
Figure 5: Municipal Office: Unsupported wood plank decking at Loft opening.

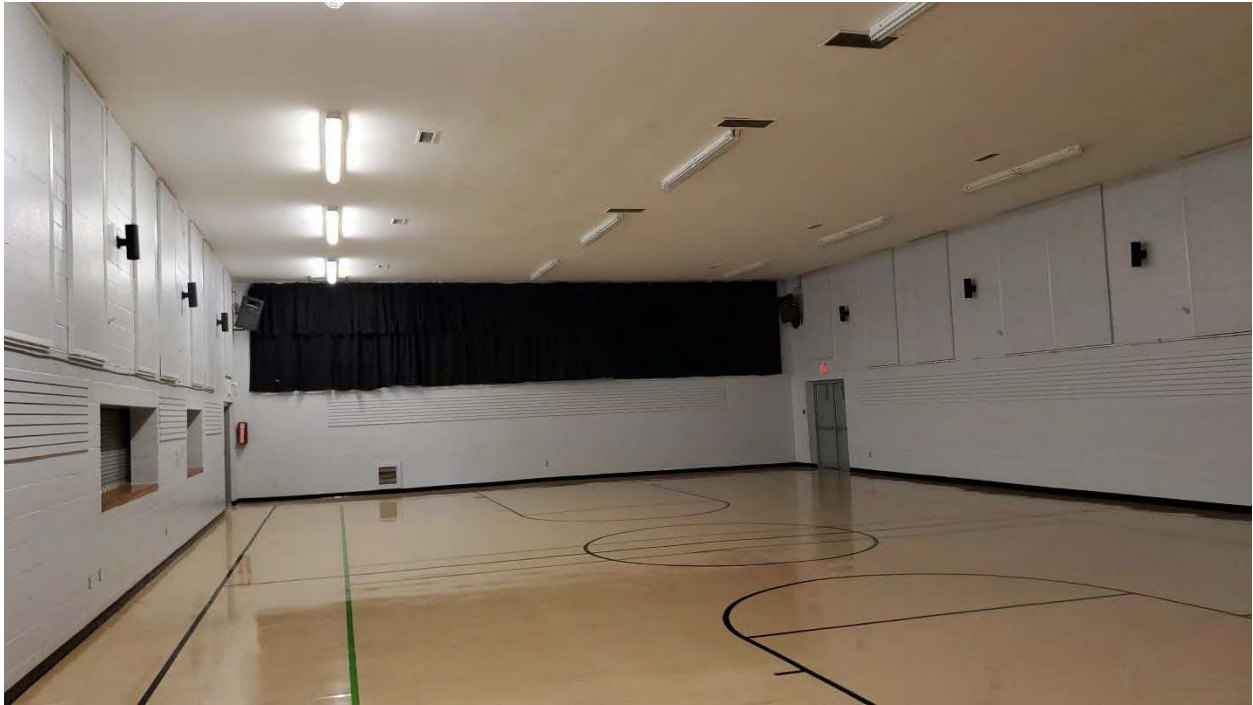
Figure 11: Community Hall Addition (Gymnasium): Looking west.

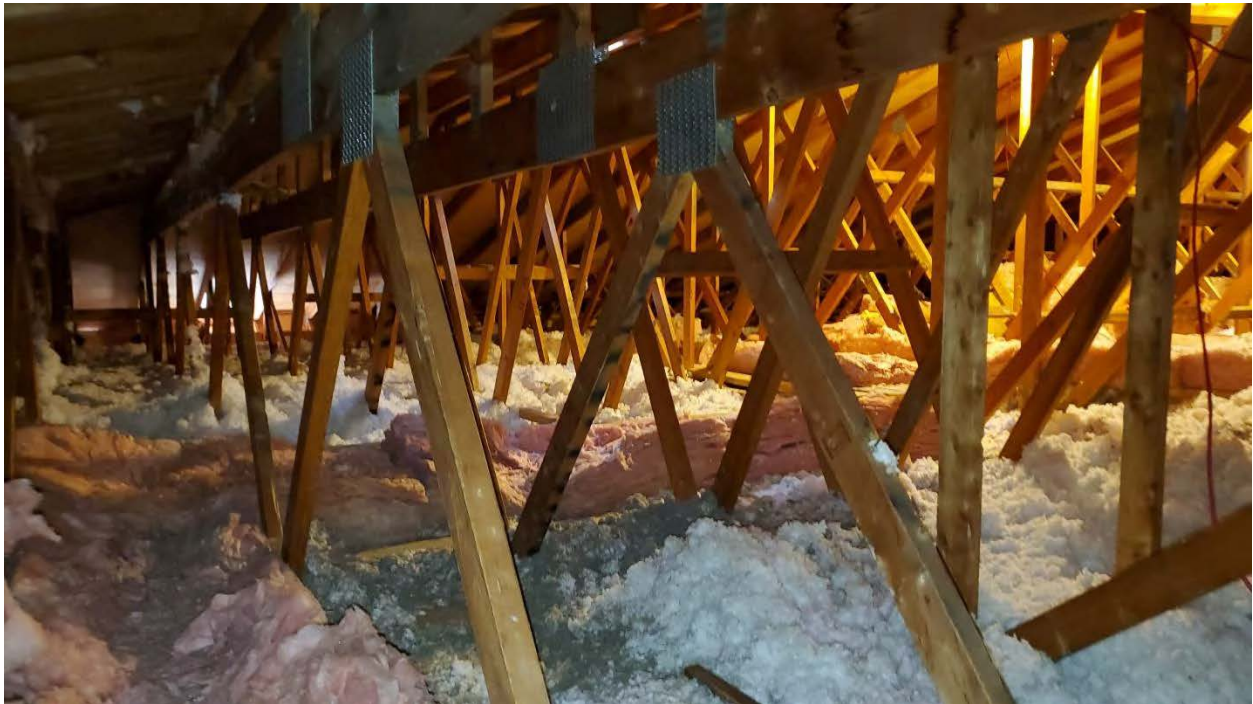
Figure 12: Community Hall Addition: Typical roof framing over Gymnasium.

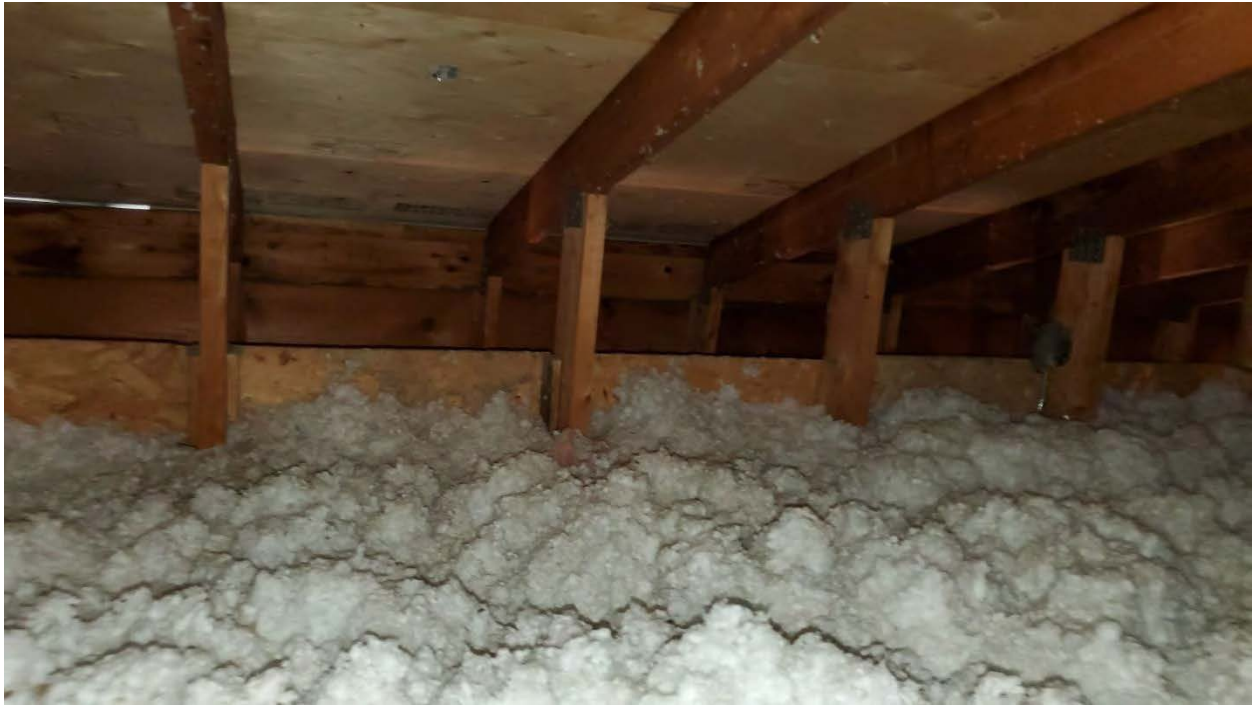
Figure 13: Community Hall Addition: Typical roof framing over Gymnasium.

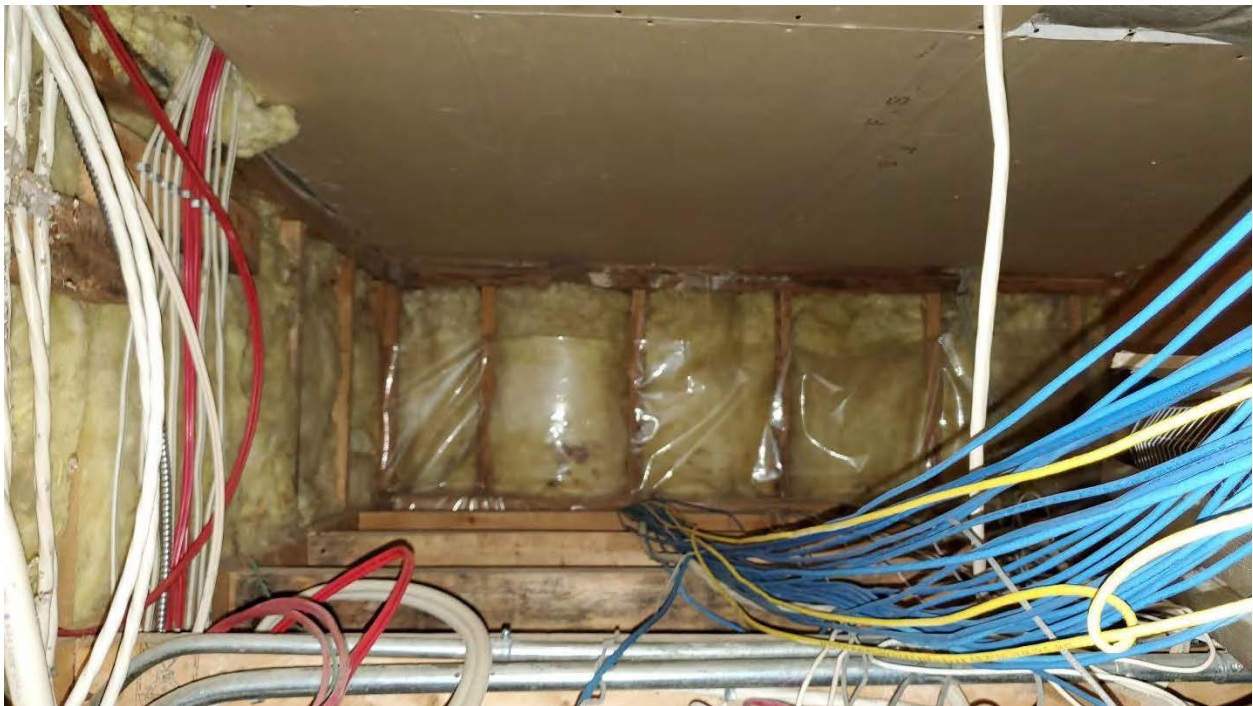
Figure 20: Electrical Room Addition: Wall framing above the ceiling in the Electrical Room.

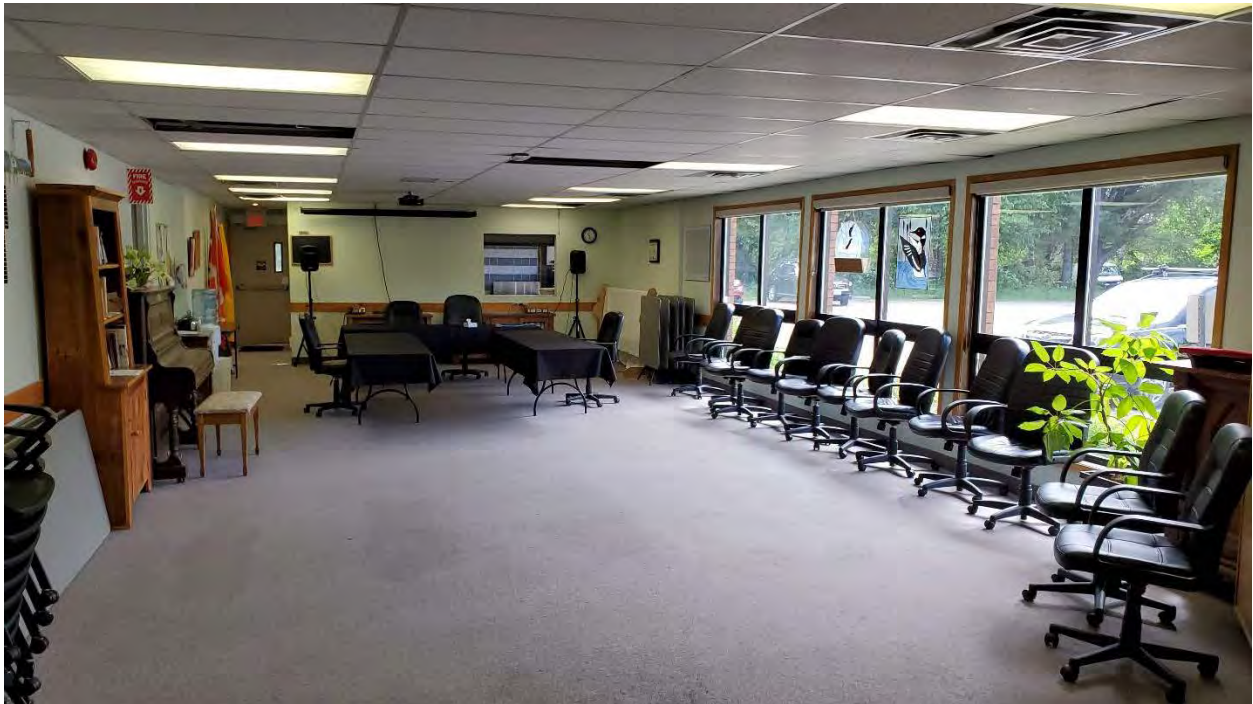
Figure 22: Community Hall Addition and Senior's Club Addition: Looking east.

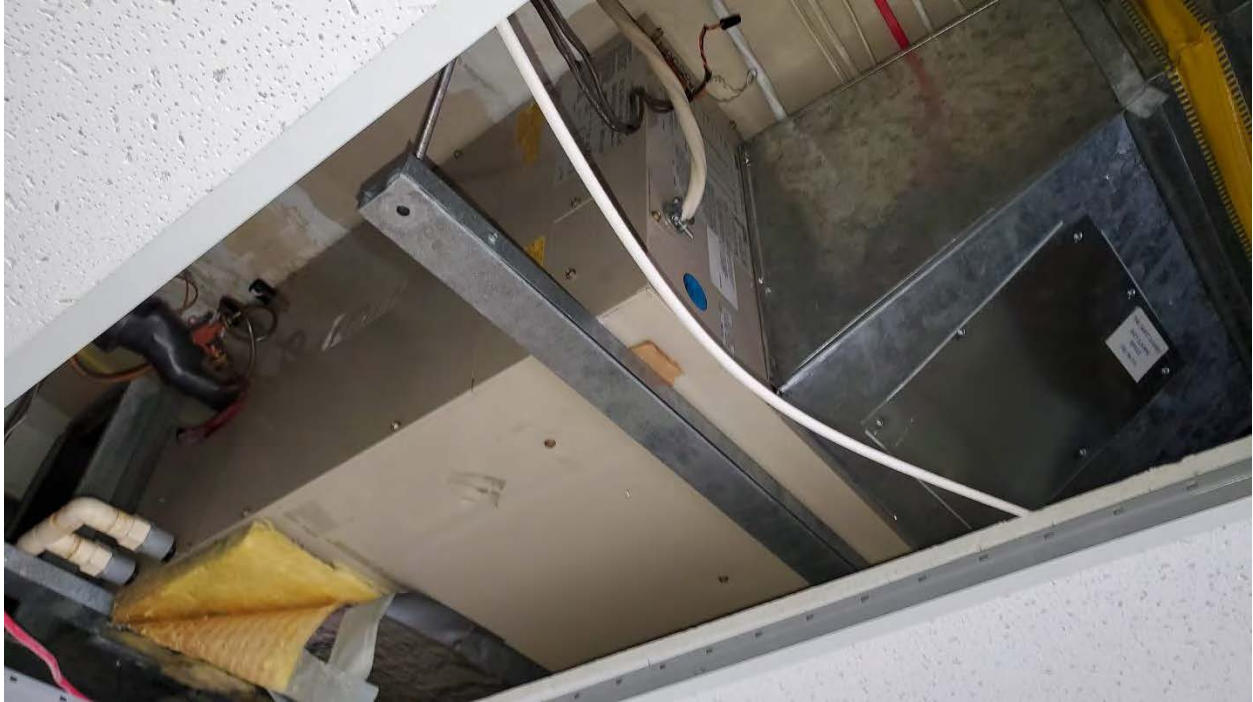
Figure 23: Community Hall Addition: Mechanical unit suspended from roof framing.

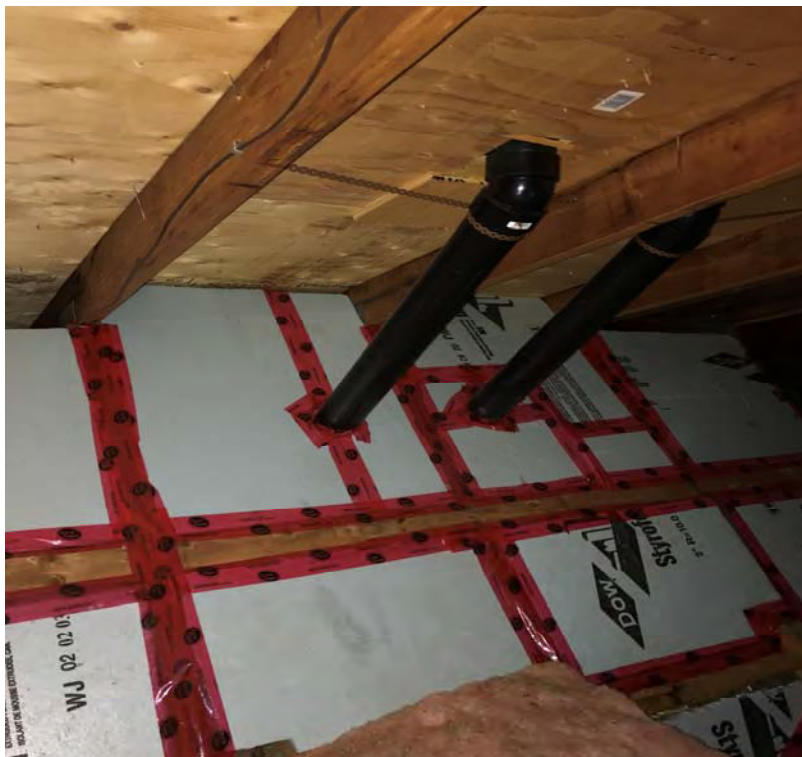
An electric furnace in the Attic Space provides heating and cooling for the Community Centre. Condensing unit is located on grade outside. There is no fresh air connection to the furnace which is required by Code. The thermostat is located in the corridor rather than in the Gym.

PHOTO OF ENCLOSED ATTIC FURANCE ABOVE GYMNASIUM

- a) Furnace is very old and is not suitable for the Gym. There is no fresh air also which is against the Code. A new H.V.A.C. unit with fresh air is required to be provided soon.
- b) There is no fresh air in the other rooms also in the Community Centre. A supply air needs to be provided by a separate unit in these rooms to meet the Code.
- c) Kitchen hood needs to be replaced with NFPA approved hood and a make-up air unit also is required.
- d) Washroom fixtures are very old and should be replaced.

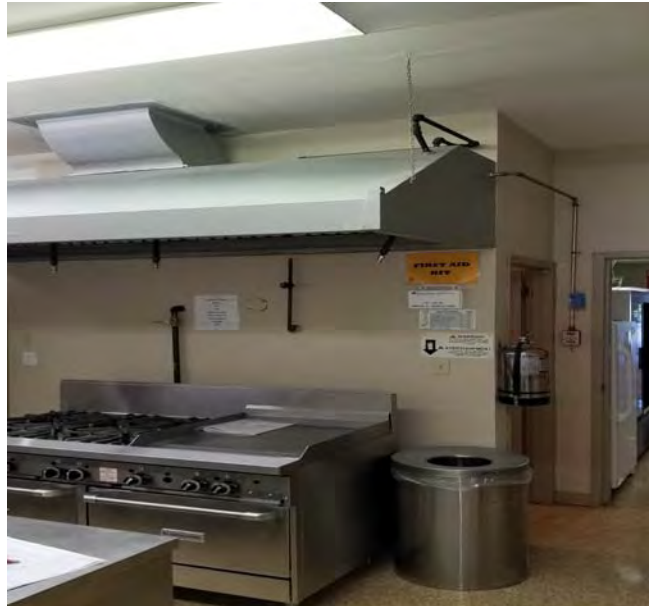
There is a hood for the kitchen for the Community Centre with suppression system but hood does not appear to be NFPA Compliant. Further checking would be required. There is also no make-up air for the hood exhaust. In Commercial Kitchens fresh air is required to make up for the exhaust.

PHOTO OF EXHAUST HOOD (SENIOR'S CLUB KITCHEN)

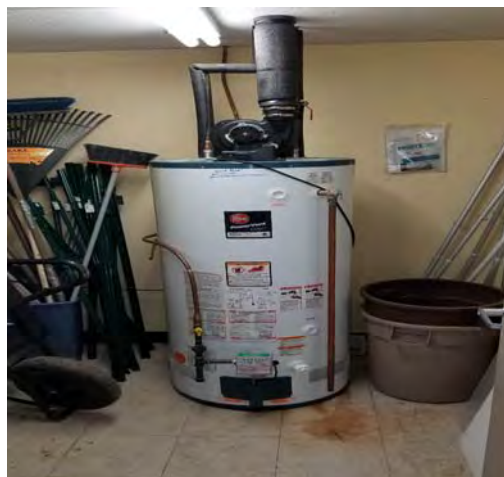
There is a domestic hot water propane-fired heater in good condition.

PHOTO OF DOMESTIC HOT WATER HEATER (IN THE COMMUNITY CENTRE)

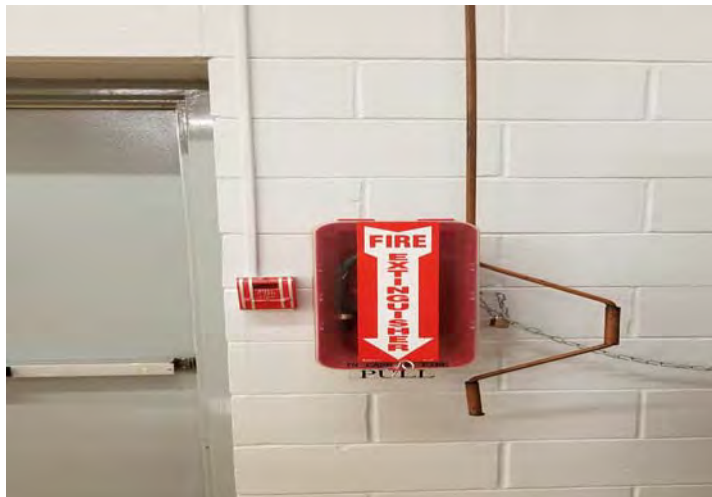
There is no sprinkler or stand-pipe system in this building but there are fire extinguishers.

PHOTO OF FIRE EXTINGUISHER (IN THE GYM)

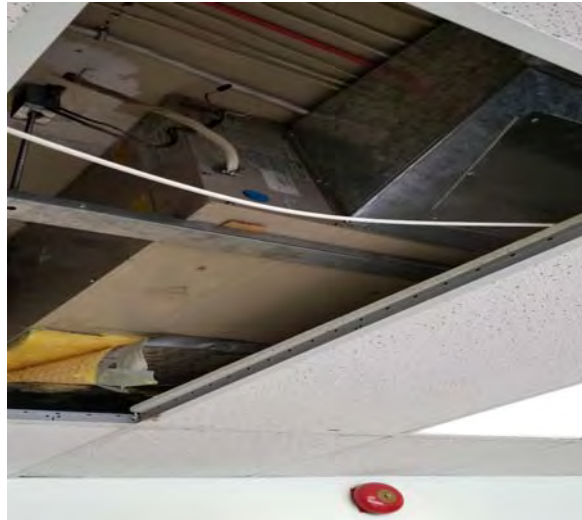
A fan coil unit in the ceiling space with electric coil provides heating and cooling for this room. Condensing unit is located outside on grade. There is no fresh air connection to the fan coil which is required by Code.

PHOTO OF FAN COIL

- a) The fan coil is only 8 years old. This type of unit has a life of 20 to 25 years. Fresh air should be added to the fan coil to meet the Code requirement.
- b) Kitchen hood needs to be replaced with NFPA approved hood and a make-up air unit also is required.
- c) Plumbing fixtures are in reasonable condition and therefore do not require immediate replacement.

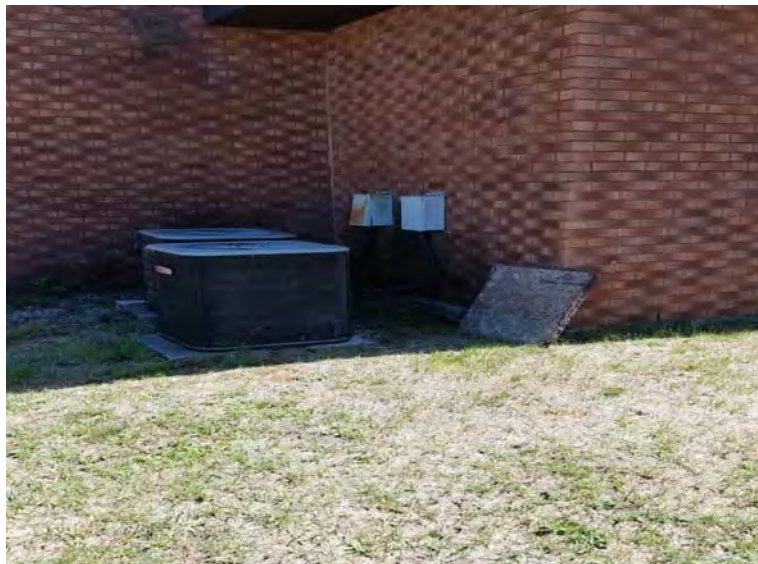
PHOTO OF CONDENSING UNIT (SERVING SENIOR'S CLUB AND OFFICE)

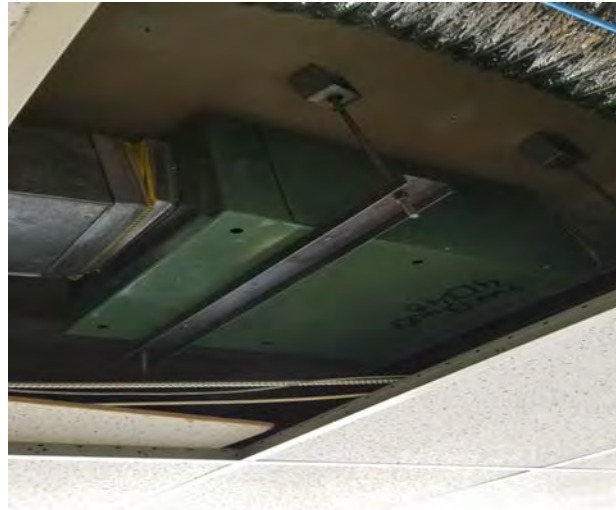
There is an exhaust fan in the ceiling of the Seniors Club. It is not functional.

PHOTO OF EXHAUST FAN (IN CEILING OF SENIOR'S CLUB)

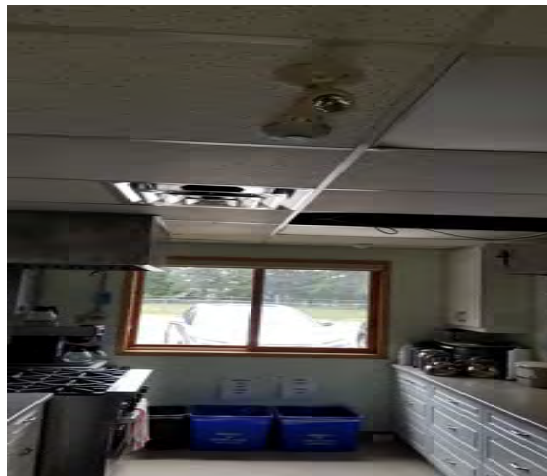
There is an exhaust fan in the washroom. There is a hood for the kitchen for the for the Seniors Lounge with suppression system but hood does not appear to be NFPA Compliant. It needs further checking. In Commercial Kitchens, fresh air is required to make up for the exhaust.

There is also no make-up air for the hood exhaust.

PHOTO OF EXHAUST HOOD (IN THE SENIOR'S CLUB KITCHEN)

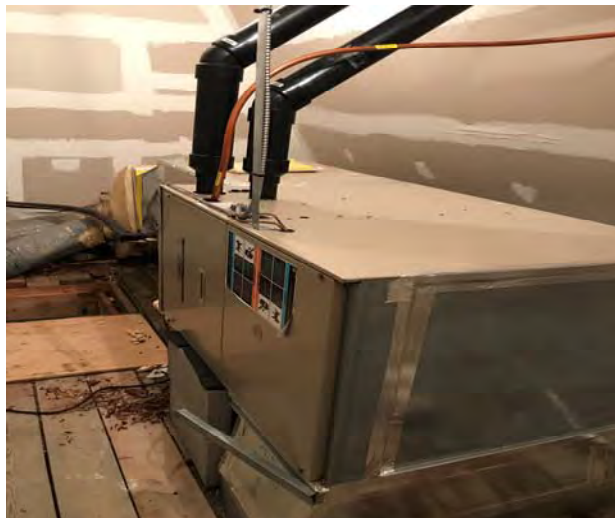
A gas-fired furnace in the Attic Space provides heating and cooling for the Offices and the Library. A condensing unit is located outside on grade. There is no fresh air connection to the furnace which is required by Code.

PHOTO OF FURNACE (IN THE ATTIC SPACE OF OFFICE CORRIDOR)

- a) The furnace is only eight years old. It has a life of approximately 15 years and therefore will require replacement in 5 to 10 years but fresh air should be added to meet the Code requirement.
- b) Washroom fixtures are in good condition and do not require replacement.
- c) Exhaust should be provided from the Electrical Room with the Slop Sink.

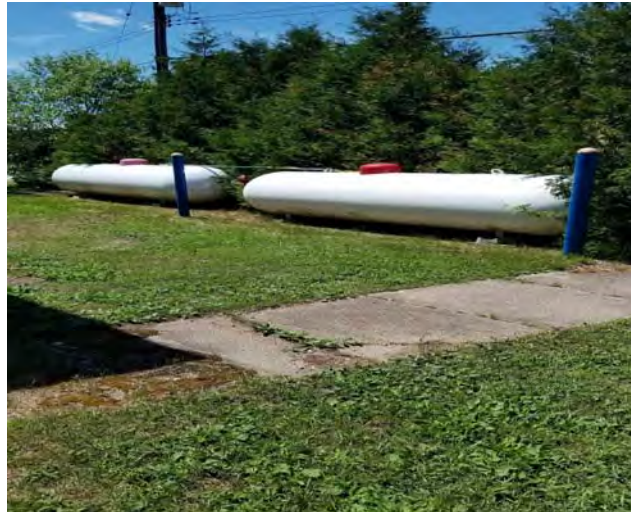
There is no natural gas available. Two propane tanks are located on the property.

PHOTO OF PROPANE TANK

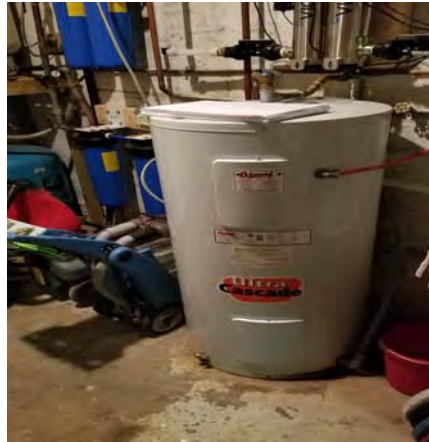
There is a propane-fired hot water heater. It is in reasonably good condition.

PICTURE OF HOT WATER HEATER

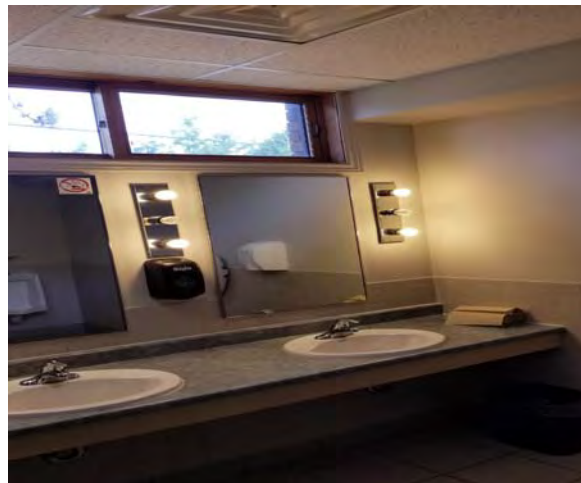
Plumbing fixtures were replaced in the last few years and they are in very good condition.

PICTURE OF WASHROOM FIXTURES

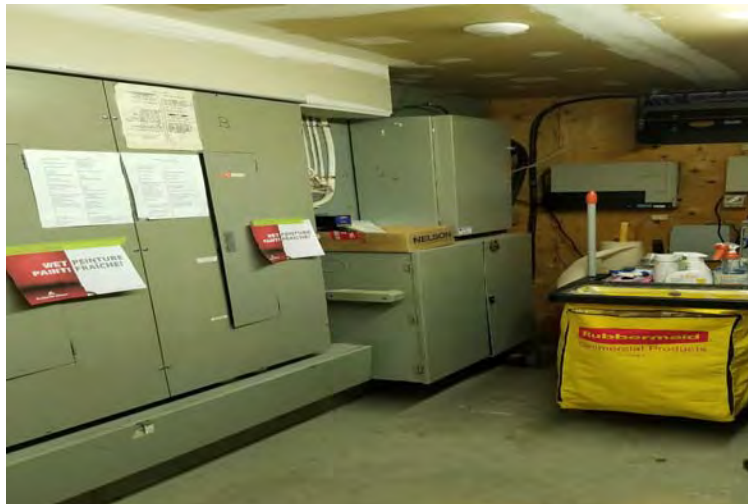
The existing main service is rated 600Amp at 120/208V, three phase, 4 wires and includes 600Amp main fused disconnect switch, utility metering cabinet and 600Amp main power distribution panel. The main distribution panel is feeding sub-electrical panels throughout the building and some other mechanical equipment such as air conditioning units and other loads as well. The main power distribution panel is out-dated but in fair condition.

EXISTING MAIN POWER DISTRIBUTION SYSTEM AT THE MAIN ELECTRICAL ROOM

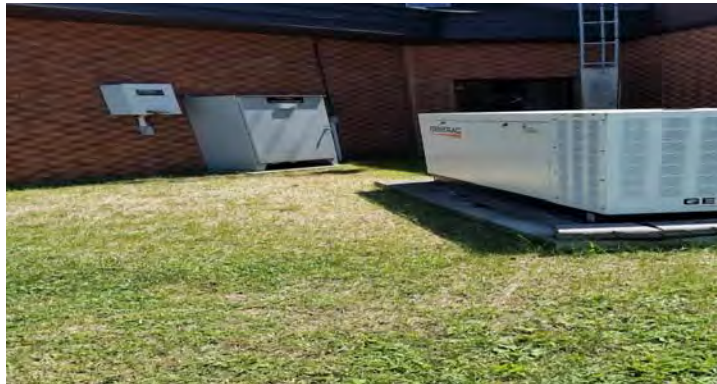
The building has an outdoor power backup generator located on concrete pad on grade and near the electrical room. The generator is connected to an outdoor wall mounted automatic transfer switch located on the exterior wall of the electrical room. The generator provides power backup for the entire building in case of hydro power failure through the automatic transfer switch.

EXISTING OUTDOOR GENERATOR AND AUTOMATIC TRANSFER SWITCH

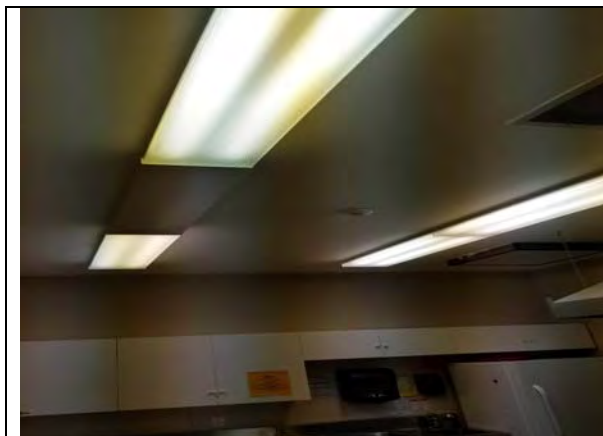
Existing fluorescent light fixture at the kitchen

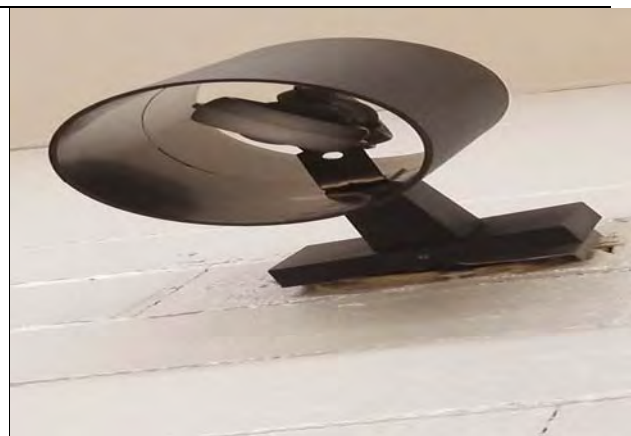
Existing incandescent light fixture at the Gym

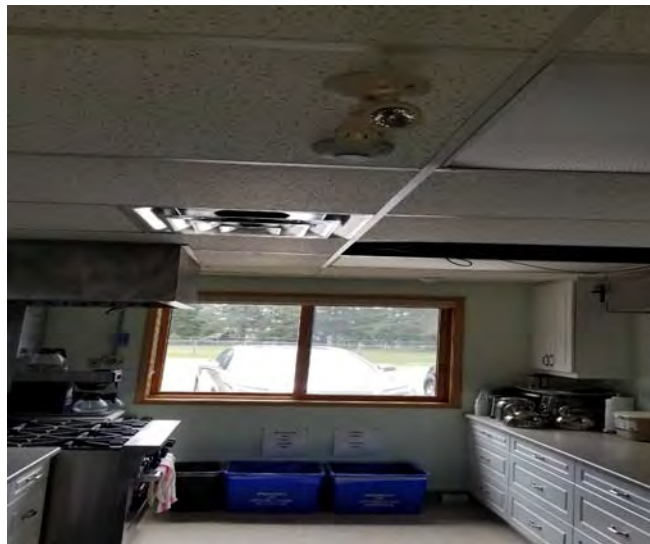
The existing emergency lighting system consists of exit lights, emergency lighting remote heads and battery units. The majority of the emergency light fixtures and battery units appear to be out-dated.

EXISTING EMERGENCY LIGHTING

1. Exit and emergency lights are out-dated. The layout of the existing emergency lighting system does not comply with the current code requirements where additional fixtures shall be added in the library, municipal office, common washrooms, etc. for proper coverage. We recommend to replace the existing out-dated exit lights with new energy efficient LED type, pictogram 'running man' exit lights to meet the current requirements of MNECB and OBC.

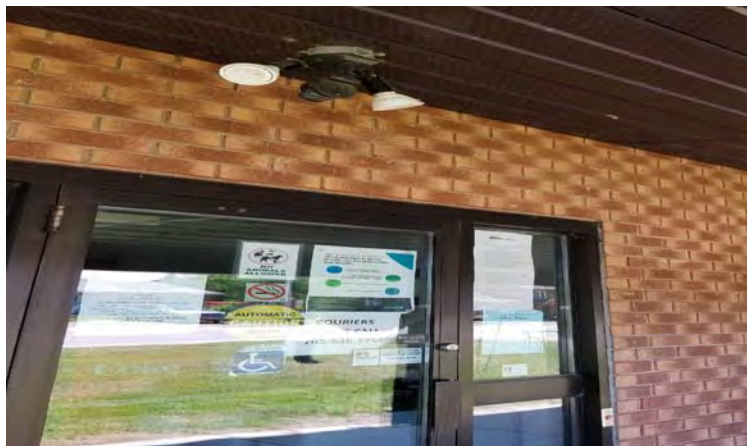
Existing exterior lighting consists of surface mount light fixtures with motion detectors.

EXISTING EXTERIOR LIGHT FIXTURE WITH MOTION DETECTOR

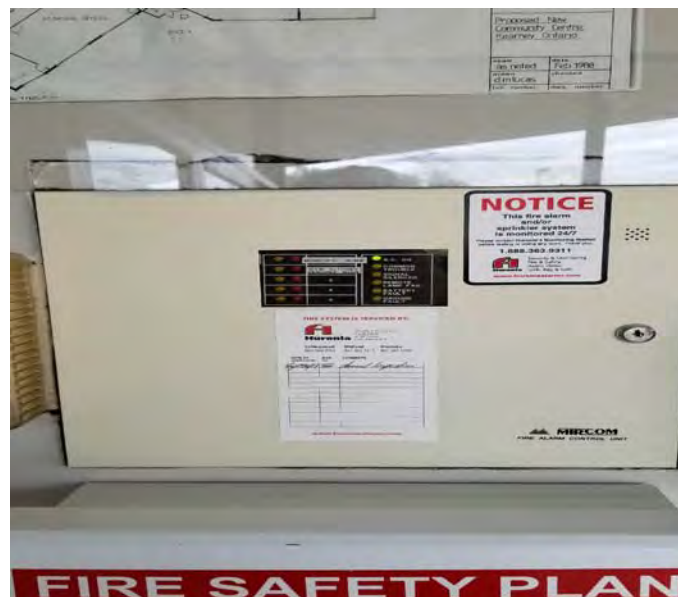
The existing main fire alarm system is by Mircom which consists of the main fire alarm control panel located at the main entrance of the building, fire alarm detectors, fire alarm bells and fire alarm manual pull stations. The existing fire alarm system appears to be in good condition.

EXISTING MAIN FIRE ALARM CONTROL PANEL
