AGENDA

REGULAR COUNCIL MEETING
Council Chambers
Friday, August 7th, 2020 – 1:00 p.m.

(i) **Sonya Clelland, Project Manager Englobe Corp. - North Bay re:**
[Draft Building Condition Assessment for the Municipal Office Building](#)

Building Condition Assessment

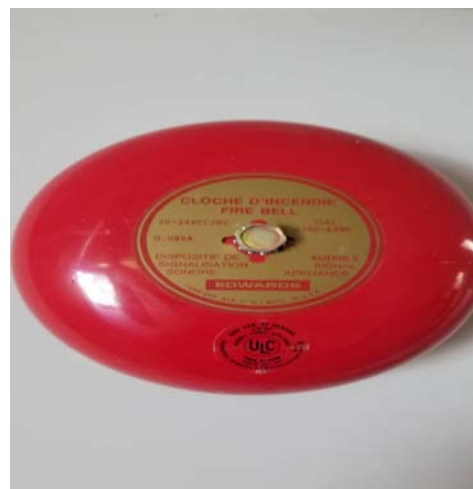
EXISTING FIRE ALARM SIGNALING DEVICE

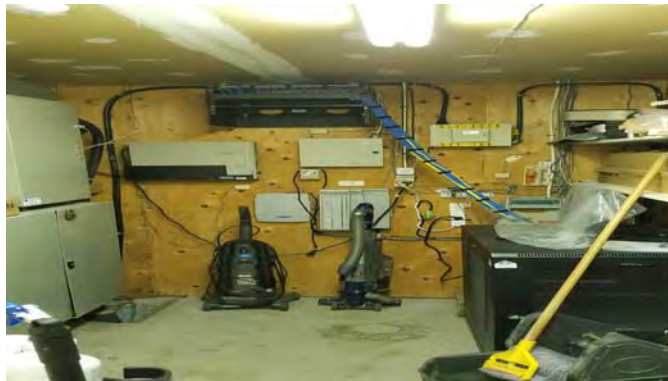
Security Intrusion alarm system consists of motion detectors and doors contacts installed throughout the building which appears to be in fair condition. The existing main control panel of the security system is located at the main electrical room.

EXISTING INTRUSION ALARM CONTROL PANEL, TELEPHONE SWITCH AND IT CABINET LOCATED AT THE MAIN ELECTRICAL ROOM

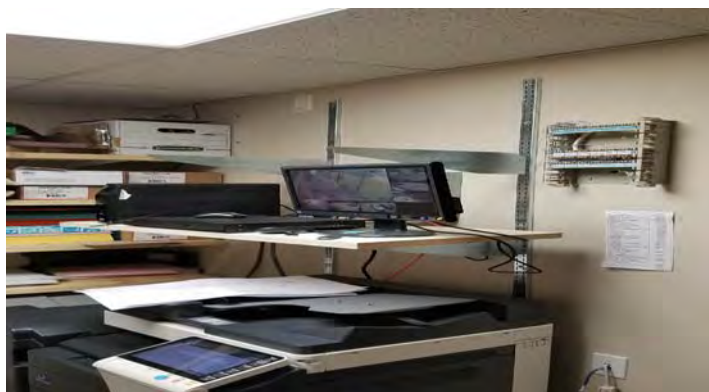
The building is equipped with CCTV system, the front-end equipment is located at the file room within the office area. There are interior and exterior cameras distributed within the office area and around the exterior of the building.

EXISTING CCTV SYSTEM AT THE FILE ROOM WITHIN THE OFFICE AREA

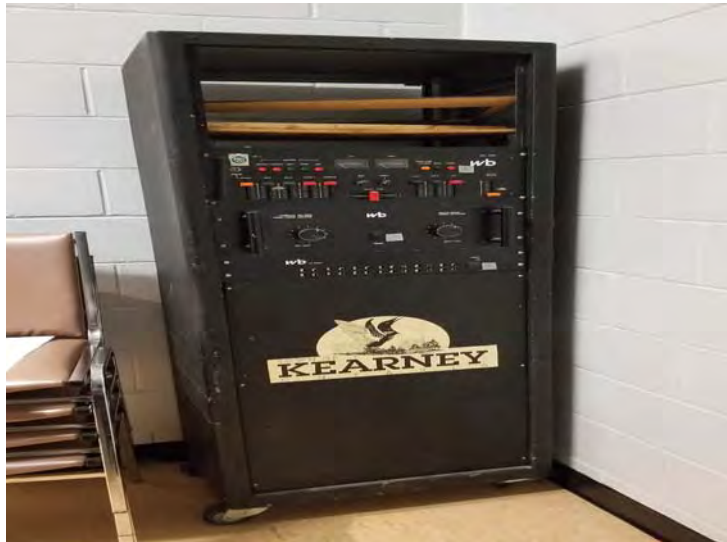
Local sound systems are provided in the Gym area and the senior game room with wall mounted speakers installed within the respective areas. The gym includes a portable local sound system rack.

EXISTING LOCAL SOUND SYSTEM RACK AT THE STAGE OF THE GYM

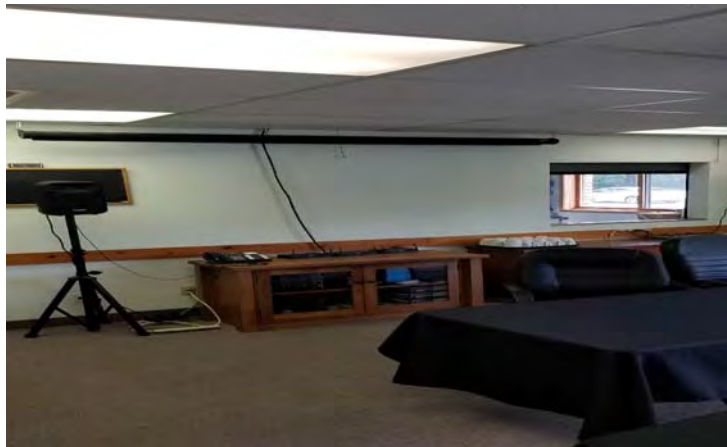
EXISTING LOCAL SOUND SYSTEM AT THE SENIOR GAME ROOM

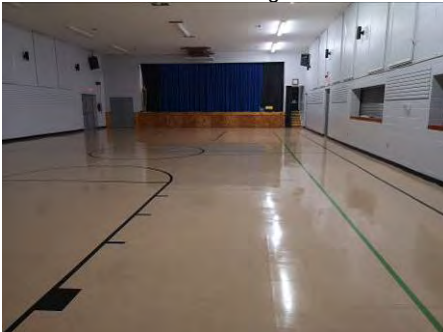
<p style="text-align: center;">07</p>	<p style="text-align: center;">Non-Mercury Containing Thermostat</p>

LOCATION/AREA:	Level 1 – Room # 1 – Gymnasium	PHOTOS: 07 – 21
Notes		
<p>Only those building materials identified as a suspect Asbestos Containing Material (ACM) and sampled have been listed. See full list for confirmed ACMs potentially present in this area. One(1) Non-Mercury Containing Thermostat was observed on south wall.</p>		
<p style="text-align: center;">Overview Facing East</p>

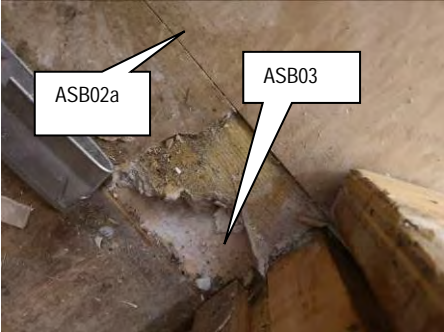
<p style="text-align: center;">11</p>

Location	Suspect Materials	Colour	Sample No.	Analytical Results % Type or ppm	Photo #	Friability	Condition Rating	Disruption Rating	Anticipated Removal Type
Floor - Below Stage	Vinyl Tile (12"x12")	Pink	ASB02a	None Detected	11	Friable	1	2	-
Floor – Near Gym Door Along South Wall	Vinyl Tile (12"x12")	Pink	ASB02b	None Detected	12	Friable	1	2	-
Floor – Stairs to Gym Stage	Vinyl Tile (12"x12")	Pink	ASB02c	None Detected	13	Friable	1	2	-
Below Vinyl Tile Floor	Fiberboard	White	ASB03a	None Detected	11	Friable	1	2	-
Below Vinyl Tile Floor	Fiberboard	White	ASB03b	None Detected	11	Friable	1	2	-
Below Vinyl Tile Floor	Fiberboard	White	ASB03c	None Detected	11	Friable	1	2	-
North Wall - East Door	Baseboard Mastic	White	ASB04a	None Detected	14	Friable	1	2	-
South Wall - South East Door	Baseboard Mastic	White	ASB04b	None Detected	15	Friable	1	2	-
South Wall - South West Door	Baseboard Mastic	White	ASB04c	None Detected	16	Friable	1	2	-

Ceiling Above Stage	Drywall Joint Compound	White	ASB05a	None Detected	17	Friable	1	2	-
Below ASB02b	Construction Mastic	Yellow	ASB06a	None Detected	11	Non-Friable	1	2	-

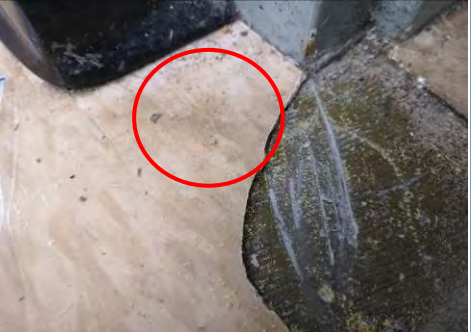
<p style="text-align: center;">12</p>

LOCATION/AREA:		Level 1 – Room # 1 – Gymnasium (Continued)					PHOTOS: 07 – 21			
Location	Suspect Materials	Colour	Sample No.	Analytical Results % Type or ppm	Photo #	Friability	Condition Rating	Disruption Rating	Anticipated Removal Type	
Below ASB02a	Construction Mastic	Yellow	ASB06b	None Detected	12	Non-Friable	1	2	-	
Below ASB02b	Construction Mastic	Yellow	ASB06c	None Detected	13	Non-Friable	1	2	-	
South Wall	Mortar	Grey	ASB10c	None Detected	18	Non-Friable	1	3	-	
Painted Tile on North Wall	Ceiling Tile (2'x4')	Brown	ASB15c	None Detected	19	Non-Friable	1	2	-	
South Side of Stage	Wall Paint	Grey	PB01	<77 ppm	20	-	-	-	-	
Ceiling	Ceiling Paint	White	PB02	<66 ppm	21	-	-	-	-

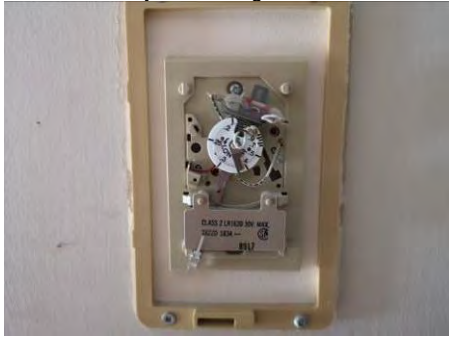
Only those building materials identified as a suspect Asbestos Containing Material (ACM) and sampled have been listed. See full list for confirmed ACMs potentially present in this area. One (1) Mercury Containing Thermostat was observed on the south wall.

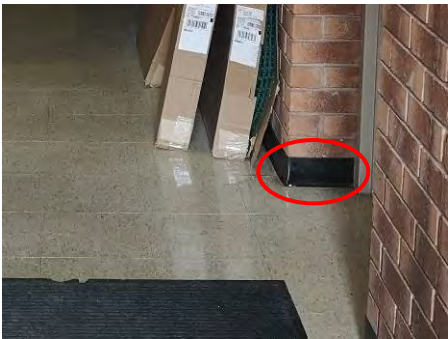
Location	Suspect Materials	Colour	Sample No.	Analytical Results % Type or ppm	Photo #	Friability	Condition Rating	Disruption Rating	Anticipated Removal Type
Behind Northwest Baseboard	Construction Mastic	Yellow	ASB07a	None Detected	25	Non-Friable	1	2	-
North Wall	Brick Mortar	Brown	ASB08a	None Detected	26	Non-Friable	1	3	-
Ceiling	Ceiling Tile (2'x4')	Brown	ASB09a	None Detected	28	Friable	1	2	-
North Wall	Block Concrete Mortar	Grey	ASB10a	None Detected	27	Non-Friable	1	3	-
Floor	Vinyl Tile (12"x12")	Beige	ASB11a	None Detected	29	Non-Friable	1	3	-
Sublayer of ASB11a, Identified by the Laboratory	Construction Mastic	Black	ASB11ai	None Detected	29	Non-Friable	1	2	-
Floor – Below Vinyl Tile	Construction Mastic	Black	ASB12a	None Detected	29	Non-Friable	1	3	-
Ceiling	Ceiling Tile (2'x4')	Brown	ASB15a	None Detected	28	Friable	1	2	-

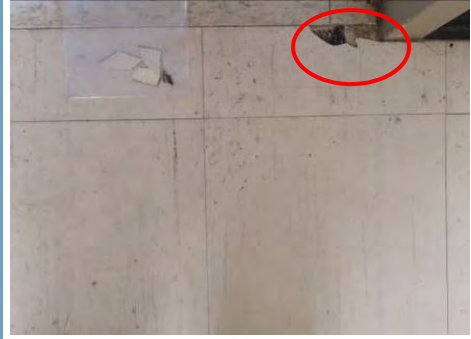
34			35			36			
Location	Suspect Materials	Colour	Sample No.	Analytical Results % Type or ppm	Photo #	Friability	Condition Rating	Disruption Rating	Anticipated Removal Type
Floor – Below Vinyl Tile	Construction Mastic	Black	ASB12c	None Detected	36	Non-Friable	1	3	-
Floor	Vinyl Tile (12"x12")	White & Grey	ASB14a	None Detected	36	Non-Friable	1	3	-

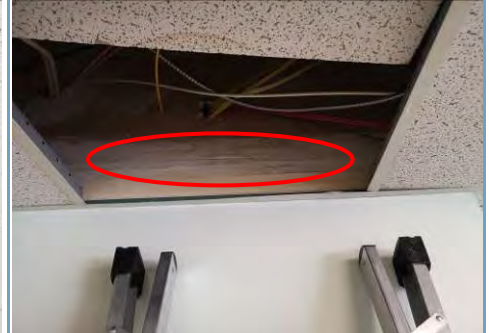
Location	Suspect Materials	Colour	Sample No.	Analytical Results % Type or ppm	Photo #	Friability	Condition Rating	Disruption Rating	Anticipated Removal Type
Ceiling	Drywall Joint Compound	White	ASB05c	None Detected	48	Friable	1	2	-
Behind Northwest Baseboard	Construction Mastic	Yellow	ASB07b	None Detected	49	Non-Friable	1	2	-
Ceiling	Ceiling Tile (2'x4')	Brown	ASB09b	None Detected	48	Friable	1	2	-
Below Carpet	Carpet Adhesive	Yellow	ASB17a	None Detected	50	Non-Friable	1	2	-
Floor in Storage Room	Vinyl Tile (12"x12")	Grey	ASB18a	None Detected	51	Non-Friable	1	3	-

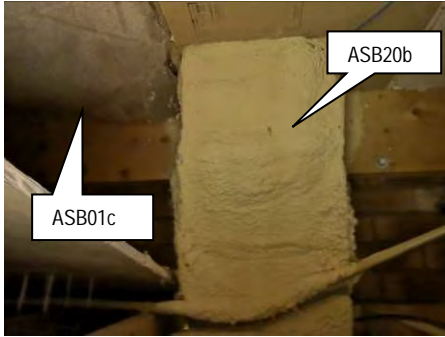
<p>61</p>						
Location	Suspect Materials	Colour	Sample No.	Analytical Results % Type or ppm	Photo #	Friability	Condition Rating	Disruption Rating	Anticipated Removal Type
Floor	Insulation	Grey	ASB01c	None Detected	61	Friable	1	2	-
East Ductwork	Foam Insulation	Yellow	ASB20b	None Detected	61	Friable	1	2	-

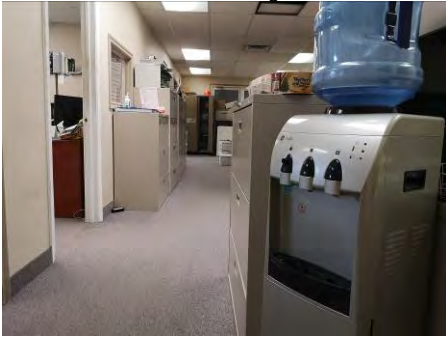
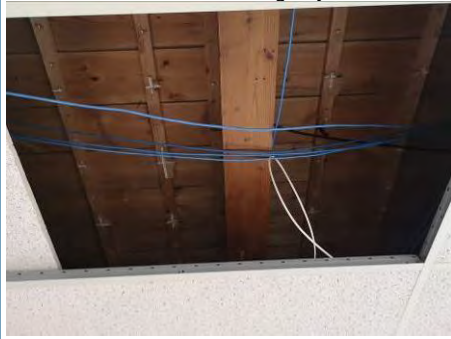
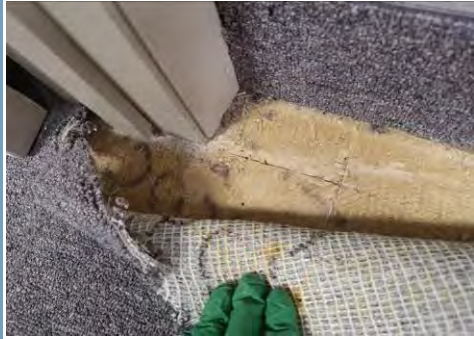
<u>LOCATION/AREA:</u>		Level 1 – Room # 12 – Offices					PHOTOS: 72 – 74			
<u>Notes</u>										
Only those building materials identified as a suspect Asbestos Containing Material (ACM) and sampled have been listed. See full list for confirmed ACMs potentially present in this area.										
Overview Facing East			Overview of Ceiling Layers

72			73			74				
Location	Suspect Materials	Colour	Sample No.	Analytical Results % Type or ppm	Photo #	Friability	Condition Rating	Disruption Rating	Anticipated Removal Type	
Below Carpet	Carpet Adhesive	Yellow	ASB17c	None Detected		Non-Friable	1	2	-	
Below Carpet	Vinyl Tile	White	ASB21b	4.0% Chrysotile	74	Non-Friable	1	3	2 or 3	
Below Carpet	Vinyl Tile	White	ASB21c	Sample Not Analyzed, See ASB21b	74	Non-Friable	1	2	-

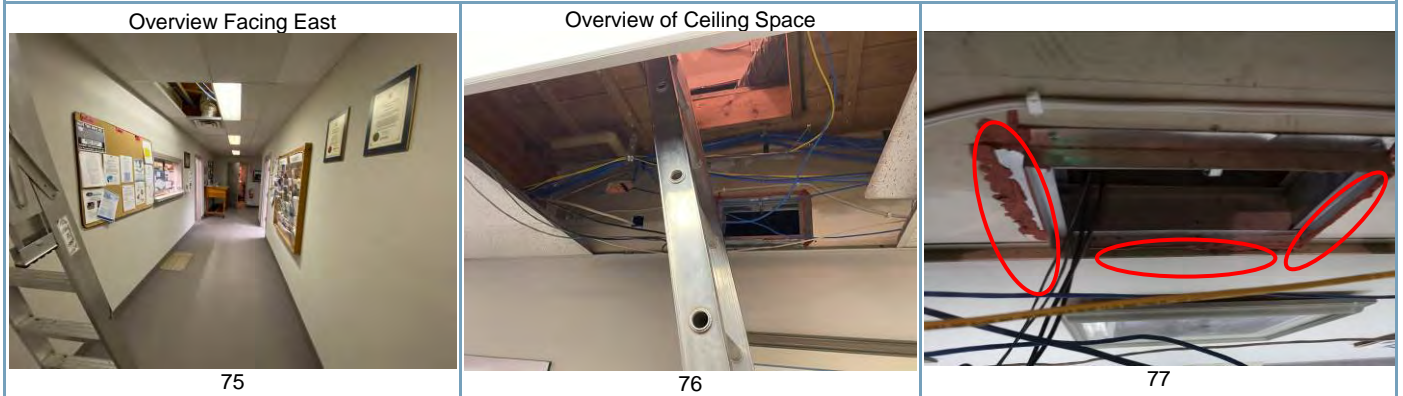
LOCATION/AREA:	Level 1 – Room # 13 – Corridor	PHOTOS: 75 – 77
-----------------------	---------------------------------------	------------------------

Location	Suspect Materials	Colour	Sample No.	Analytical Results % Type or ppm	Photo #	Friability	Condition Rating	Disruption Rating	Anticipated Removal Type
Around Vent, Above, Ceiling Tile	Caulking	Red	ASB22a	None Detected	77	Non-Friable	1	2	-
Around Vent, Above, Ceiling Tile	Caulking	Red	ASB22b	None Detected	77	Non-Friable	1	2	-
Around Vent, Above, Ceiling Tile	Caulking	Red	ASB22c	None Detected	77	Non-Friable	1	2	-

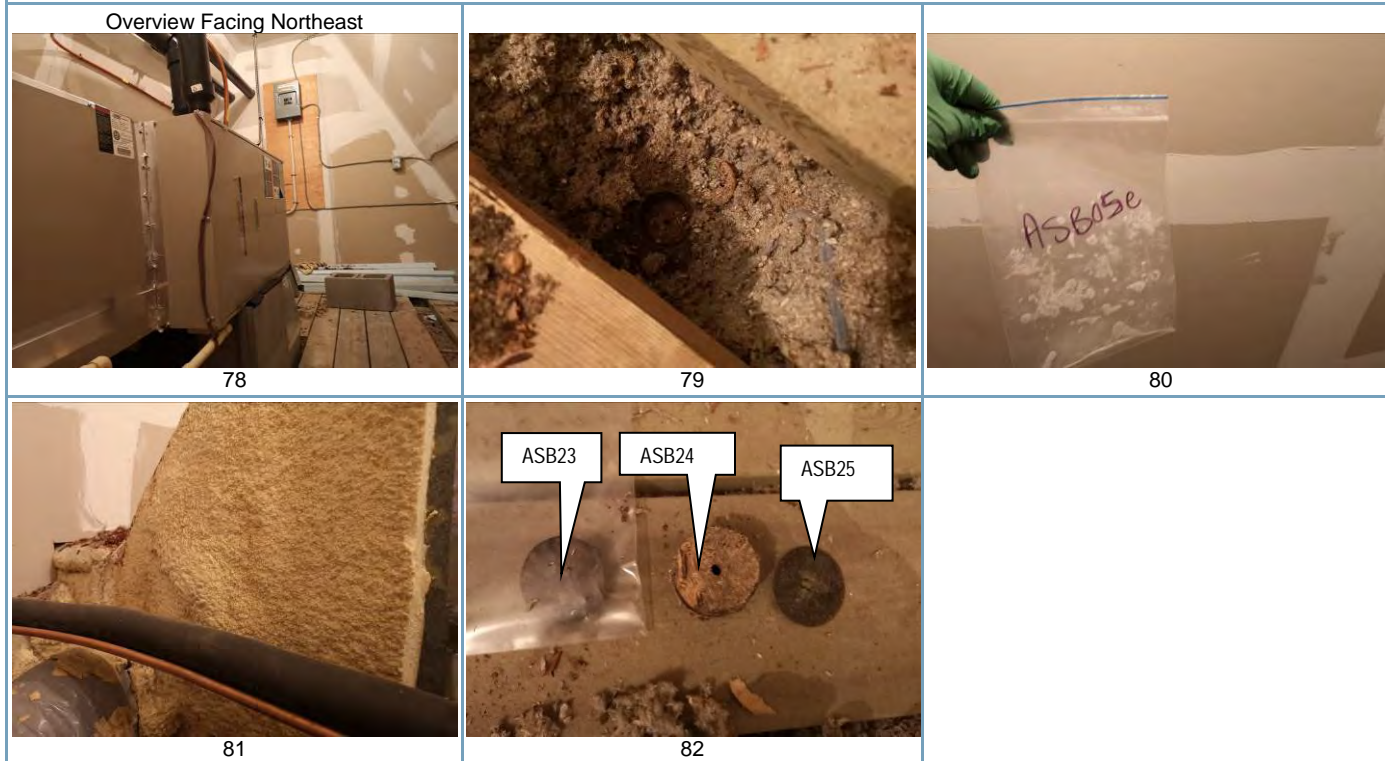
LOCATION/AREA:	Level 1 – Room # 13 – Attic #2	PHOTOS: 78 – 82
-----------------------	---------------------------------------	------------------------

Location	Suspect Materials	Colour	Sample No.	Analytical Results % Type or ppm	Photo #	Friability	Condition Rating	Disruption Rating	Anticipated Removal Type
Ceiling	Drywall Joint Compound	White	ASB05e	None Detected	80	Friable	1	2	-
Around Ductwork	Foam Insulation	Yellow	ASB20c	None Detected	81	Friable	1	2	-
Floor - First Layer	Tar	Black	ASB23a	None Detected	82	Non-Friable	1	3	-
Floor - First Layer	Tar	Black	ASB23b	None Detected	82	Non-Friable	1	3	-
Floor - First Layer	Tar	Black	ASB23c	None Detected	82	Non-Friable	1	3	-
Floor - Second Layer	Fiber Board	Brown	ASB24a	None Detected	82	Non-Friable	1	3	-
Floor - Second Layer	Fiber Board	Brown	ASB24b	None Detected	82	Non-Friable	1	3	-
Floor - Second Layer	Fiber Board	Brown	ASB24c	None Detected	82	Non-Friable	1	3	-
Floor - Third Layer	Felt/Tar Paper	Black	ASB25a	None Detected	82	Non-Friable	1	3	-
Floor - Third Layer	Felt/Tar Paper	Black	ASB25b	None Detected	82	Non-Friable	1	3	-

Floor - Third Layer	Felt/Tar Paper	Black	ASB25c	None Detected	82	Non-Friable	1	3	-

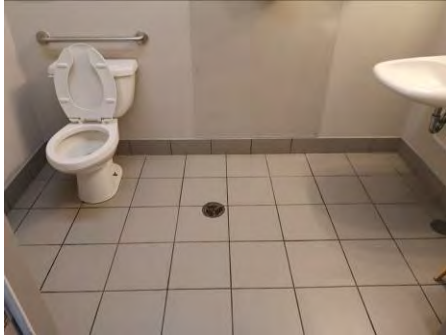
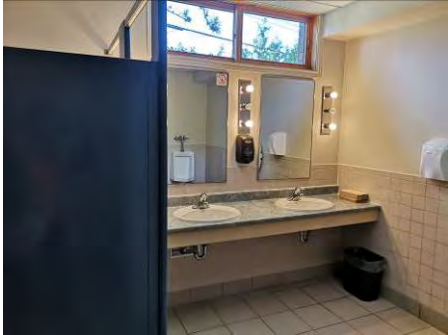
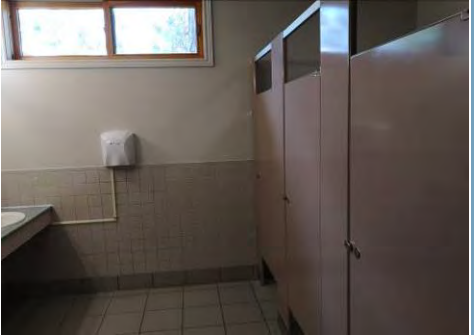
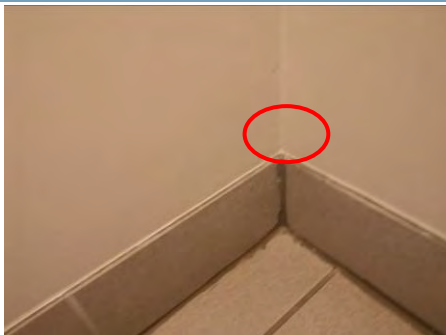
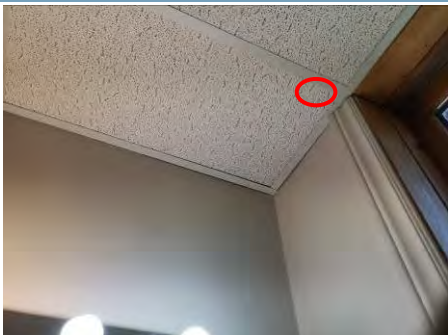
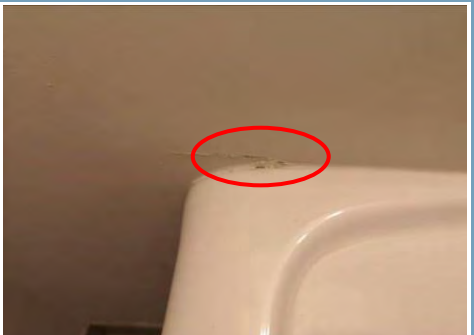
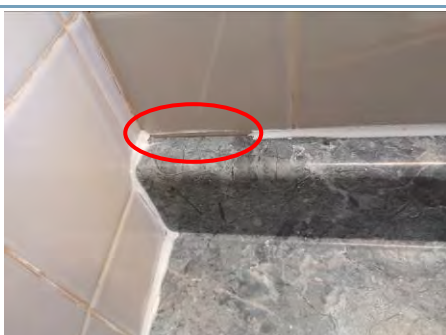
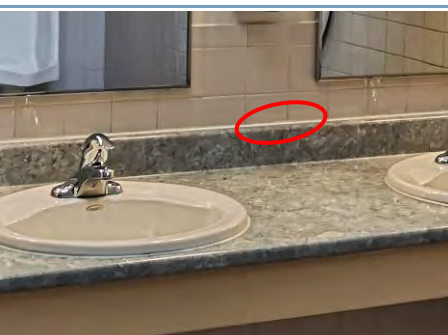
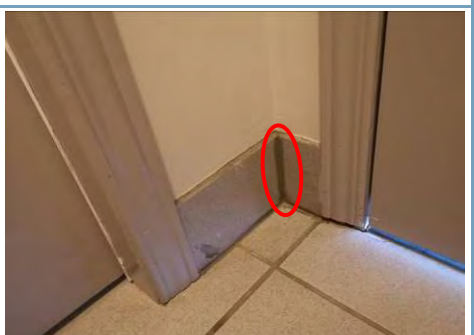
LOCATION/AREA:	Level 1 – Room # 14 – Washrooms	PHOTOS: 83 – 93
<u>Notes</u>		
Only those building materials identified as a suspect Asbestos Containing Material (ACM) and sampled have been listed. See full list for confirmed ACMs potentially present in this area.		
Overview of Multiuse Washroom Facing West	Overview of Men's Washroom Facing West	Overview of Women's Washroom Facing West

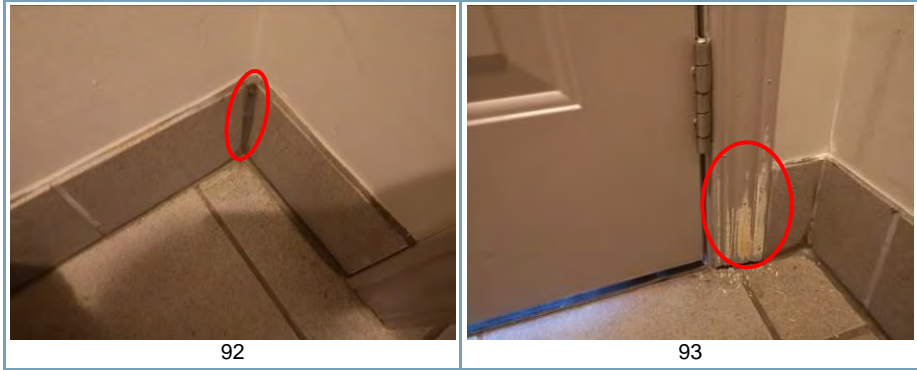
LOCATION/AREA:	Level 1 – Room # 14 – Washrooms (Continued)	PHOTOS: 83 – 93
-----------------------	--	------------------------

Location	Suspect Materials	Colour	Sample No.	Analytical Results % Type or ppm	Photo #	Friability	Condition Rating	Disruption Rating	Anticipated Removal Type
Women's Washroom West Wall	Drywall Joint Compound	White	ASB05f	None Detected	86	Friable	1	2	-
Women's Washroom Ceiling	Ceiling Tile (2'x4')	Brown	ASB09c	None Detected	87	Friable	1	2	-
Multiuse Washroom Around Sink	Caulking	White	ASB28a	None Detected	88	Non-Friable	1	3	-
Sublayer of ASB28a, Identified by the Laboratory	Drywall Joint Compound	White	ASB28a	None Detected	88	Non-Friable	1	3	-
Men's Washroom Around the Sink	Caulking	White	ASB28b	None Detected	89	Non-Friable	1	3	-
Women's Washroom Around the Sink	Caulking	White	ASB28c	None Detected	90	Non-Friable	1	3	-
Women's Washroom Around Baseboard Tile – West Side	Caulking	Grey	ASB29a	None Detected	91	Non-Friable	1	3	-
Women's Washroom Around Baseboard Tile – East Side	Caulking	Grey	ASB29b	None Detected	92	Non-Friable	1	3	-

Women's Washroom Around Baseboard Tile – East Side	Caulking	Grey	ASB29c	None Detected	92	Non-Friable	1	3	-
Door Frame	Wall Paint	Dark Beige	PB07	<42 ppm	93	-	-	-	-

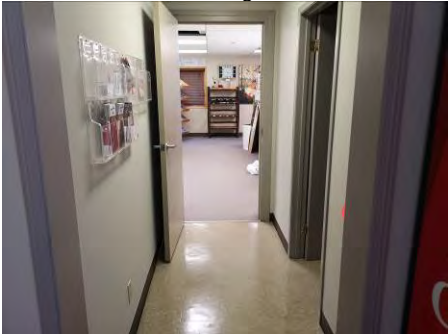
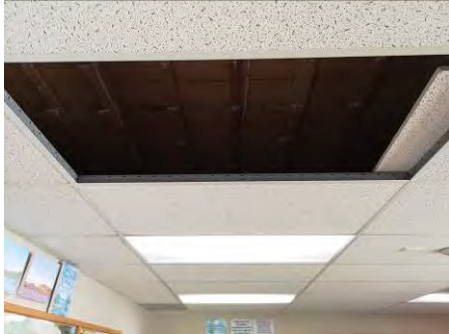
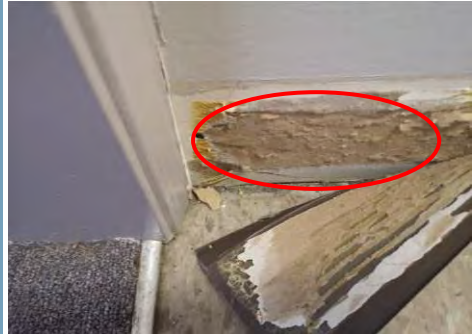
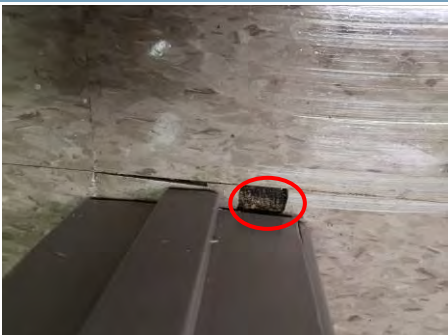
Overview Facing Southeast	Overview of Ceiling Layers

Location	Suspect Materials	Colour	Sample No.	Analytical Results % Type or ppm	Photo #	Friability	Condition Rating	Disruption Rating	Anticipated Removal Type
Behind Northwest Baseboard	Construction Mastic	Yellow	ASB07c	None Detected	96	Non-Friable	1	2	-
Floor	Vinyl Tile (12"x12")	Brown	ASB16b	None Detected	97	Non-Friable	1	3	-
Floor	Vinyl Tile (12"x12")	Brown	ASB16c	None Detected	97	Non-Friable	1	3	-
Sublayer of ASB16c, Identified by the Laboratory	Construction Mastic	Black	ASB16ci	None Detected	96	Non-Friable	1	2	-

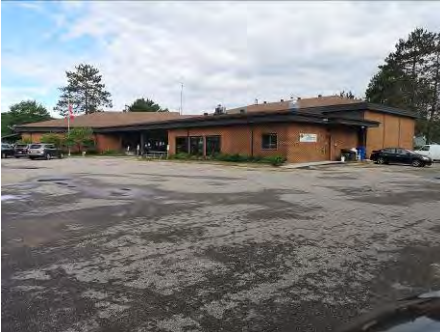
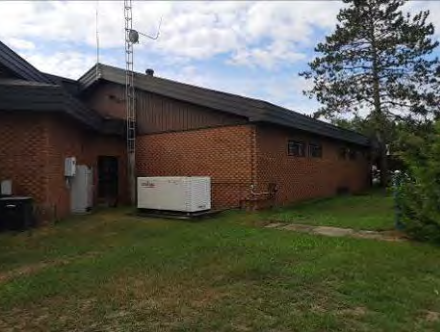
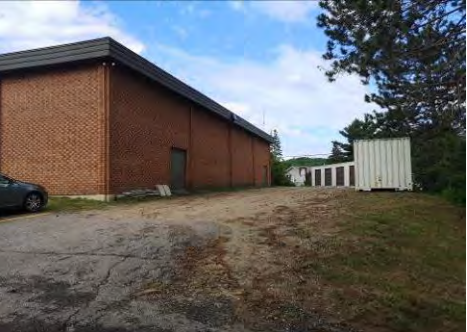
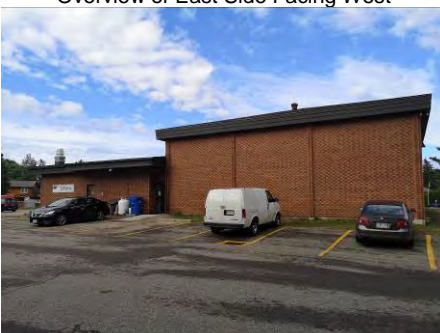
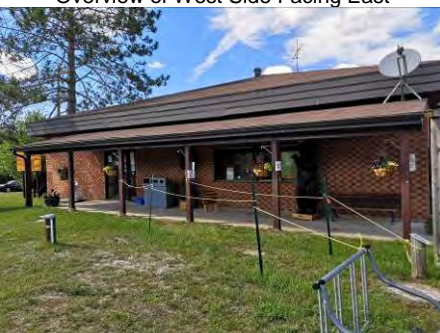
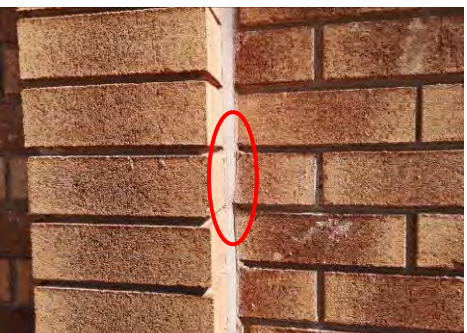
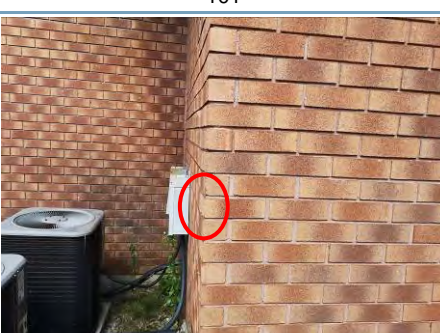
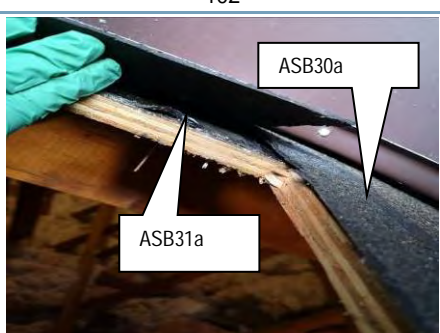
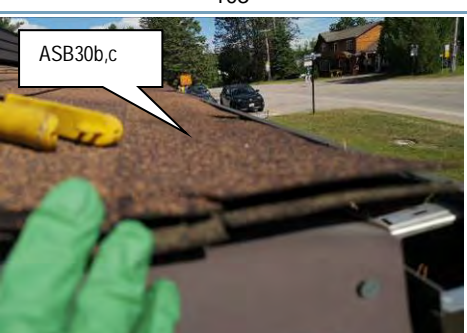
LOCATION/AREA:	Level 1 – Exterior of Community Centre	PHOTOS: 98 – 112
<u>Notes</u>		
Only those building materials identified as a suspect Asbestos Containing Material (ACM) and sampled have been listed. See full list for confirmed ACMs potentially present in this area.		
Overview of South and East Side Facing North	Overview of Northwest Side Facing West	Overview of Northeast Side Facing Northwest

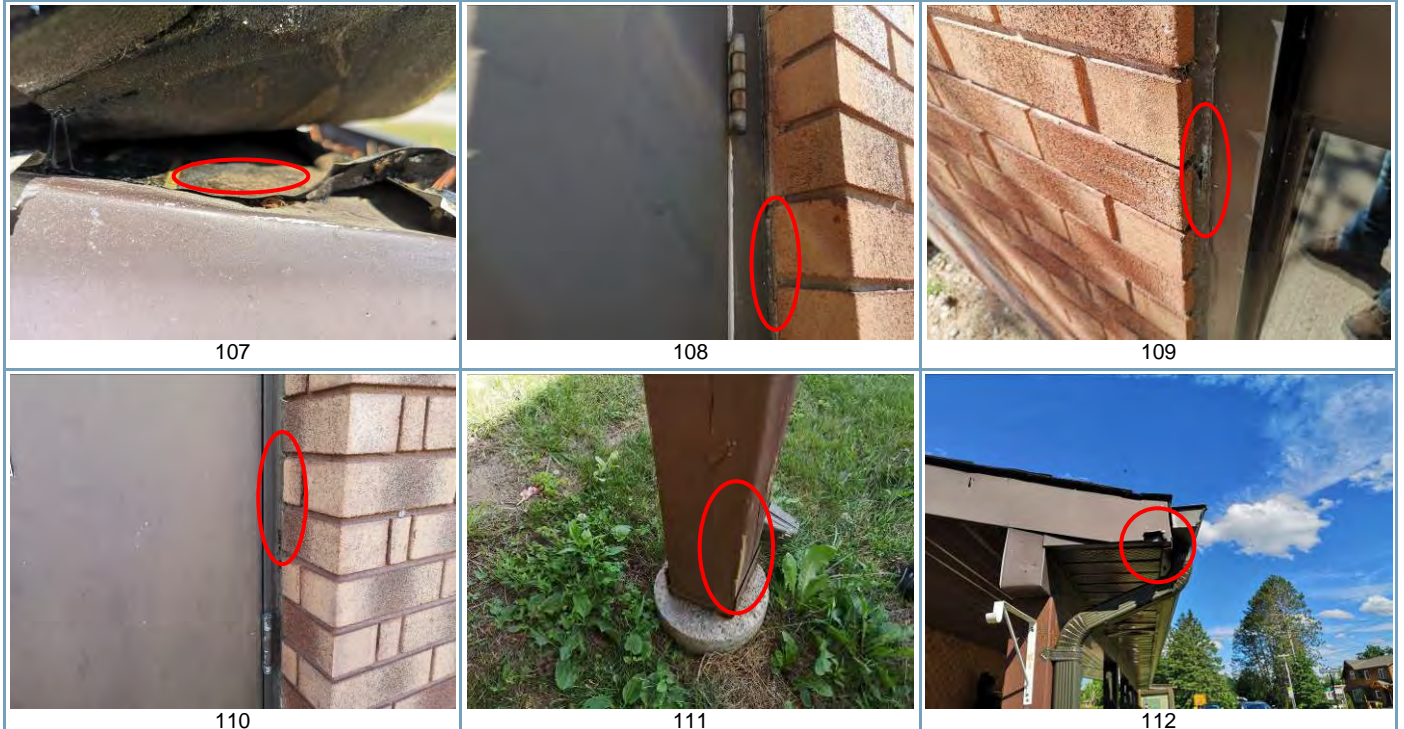
LOCATION/AREA:	Level 1 – Exterior of Community Centre (Continued)	PHOTOS: 98 – 112
-----------------------	---	-------------------------

Location	Suspect Materials	Colour	Sample No.	Analytical Results % Type or ppm	Photo #	Friability	Condition Rating	Disruption Rating	Anticipated Removal Type
North Wall	Mortar Brick	Brown	ASB08b	None Detected	103	Non-Friable	1	3	-
West Wall	Mortar Brick	Brown	ASB08c	None Detected	104	Non-Friable	1	3	-
Roof - Attic through Room 1 Vent	Roofing Shingles	Black	ASB30a	None Detected	105	Non-Friable	1	2	-
Sublayer of ASB30a, Identified by the Laboratory	Tar	Black	AB30ai	None Detected	105	Non-Friable	1	2	-
Roof - Overhang of Visitor Centre	Roofing Shingles	Black	ASB30b	None Detected	106	Non-Friable	1	2	-
Roof -Overhang of Visitor Centre	Roofing Shingles	Black	ASB30c	None Detected	106	Non-Friable	1	2	-
Roof - Attic through Room 1 Vent	Felt/Tar Paper	Black	ASB31a	None Detected	105	Non-Friable	1	2	-
Sublayer of ASB31a, Identified by the Laboratory	Tar	Black	ASB31ai	None Detected	105	Non-Friable	1	2	-
Roof - Overhang of Visitor Centre	Felt/Tar Paper	Black	ASB31b	None Detected	107	Non-Friable	1	2	-

Sublayer of ASB31b, Identified by the Laboratory	Tar	Black	ASB31bi	None Detected	107	Non-Friable	1	2	-
